Access Compliance Report

Public Rights-of-Way

(Curb Ramps)

Intersection ID: 11659	Main Street: E_16TH_ST	Cross Street: N_DAVIDSON_ST	Location: N
ADA ID: E54C552EC0C7	Ramp Type: PerpDiag	Initial Pass/Fail: Fail	Overall Compliance: No
Severity Score: 8.75			
Codes/Mitigation Info/Possible Solution		Field Measurements/Component Compliance

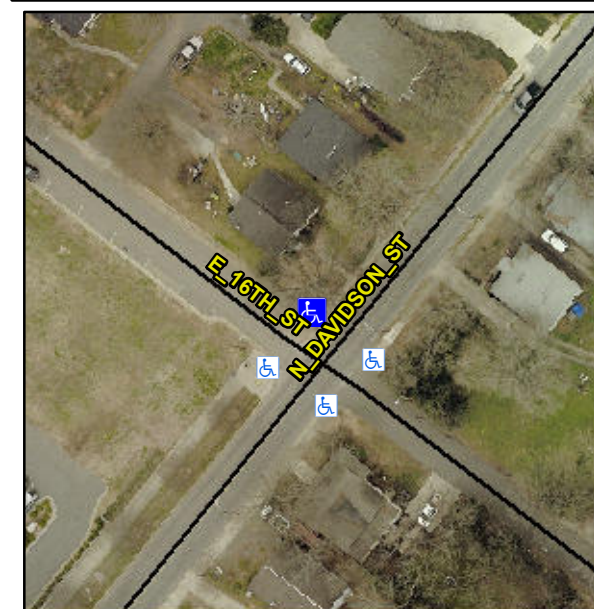
PROW/ADA:

Not Found, R304.5.1

Compliance	Description	Data	Compliance	Description	Data
N/A	Ramp Length (in)	60.0	Yes	Ramp Slope (%)	5.3
No	Ramp Width (in)	42.0	Yes	Ramp XSlope (%)	0.7
N/A	Flare Type LT	N/A	N/A	Flare Type RT	N/A
N/A	Flare Slope LT (%)	N/A	N/A	Flare Slope RT (%)	N/A
N/A	Flare Traversable LT?	N/A	N/A	Flare Traversable RT?	N/A
N/A	Landing Length (in)	N/A	N/A	DWS Provided?	N/A
N/A	Landing Width (in)	N/A	N/A	DWS Contrast?	N/A
N/A	Landing Slope (%)	N/A	N/A	DWS Length (in)	N/A
N/A	Landing X Slope (%)	N/A	N/A	DWS Full Width?	N/A
N/A	Landing Curb? (Y/N)	N/A	N/A	DWS Offset (in)	N/A
N/A	Shared Landing?	N/A			
N/A	Gutter Ponding?	Yes	N/A	Gutter Slope (%)	N/A
N/A	Gutter Lip Ht (in)	N/A	N/A	Gutter X Slope (%)	N/A
N/A	Painted X Walk1?	No	N/A	Painted X Walk2?	No
	X Walk 1 Direction	To SW		X Walk 2 Direction	To SE
N/A	X Walk 1 Width (in)	N/A	N/A	X Walk 2 Width (in)	N/A
	X Walk 1 Slope (%)	0.8		X Walk 2 Slope (%)	3.2
	X Walk 1 X Slope (%)	1.4		X Walk 2 X Slope (%)	1.4

N/A	Ramp inside XWalk1?	N/A	N/A	Ramp inside XWalk2?	N/A
	Road Slope (%)	2.8	N/A	Clear Space?	N/A
	Road X Slope (%)	1.4	N/A	Clear Space to XWalk (in)	N/A
N/A	Any Obstructions?	N/A	N/A	Storm Grate/Utility Hazard?	N/A
	Obstruction Type			Storm Grate/Utility Type	
		N/A			N/A
		Yes		Surface Condition? (G/P)	Good

Possible Solutions:

Remove & Replace Curb Ramp With Two New Directional Ramps or Equivalent.

Total Cost: \$ 3200.00
