Access Compliance Report

Public Rights-of-Way

(Curb Ramps)

Intersection ID: 20495	Main Street: BRIDLE_STONE_CT	Cross Street: STEELECHASE_DR	Location: SW
ADA ID: E55CE5E6E8A6	Ramp Type: PerpDiag	Initial Pass/Fail: Fail	Overall Compliance: No
Severity Score: 12.5			
Codes/Mitigation Info/Possible Solution		Field Measurements/Component Compliance

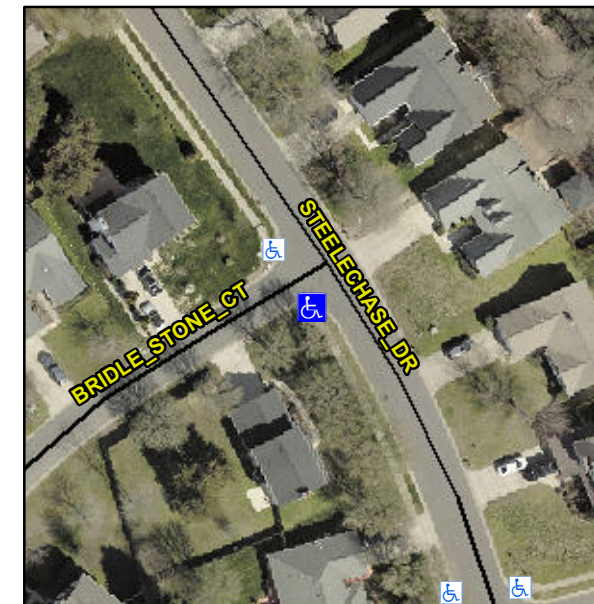
Compliance	Description	Data	Compliance	Description	Data
N/A	Ramp Length (in)	45.0	Yes	Ramp Slope (%)	6.1
Yes	Ramp Width (in)	48.0	No	Ramp XSlope (%)	6.8
N/A	Flare Type LT	N/A	N/A	Flare Type RT	N/A
N/A	Flare Slope LT (%)	N/A	N/A	Flare Slope RT (%)	N/A
N/A	Flare Traversable LT?	N/A	N/A	Flare Traversable RT?	N/A
N/A	Landing Length (in)	N/A	N/A	DWS Provided?	N/A
N/A	Landing Width (in)	N/A	N/A	DWS Contrast?	N/A
N/A	Landing Slope (%)	N/A	N/A	DWS Length (in)	N/A
N/A	Landing X Slope (%)	N/A	N/A	DWS Full Width?	N/A
N/A	Landing Curb? (Y/N)	N/A	N/A	DWS Offset (in)	N/A
N/A	Shared Landing?	N/A			
N/A	Gutter Ponding?	N/A	N/A	Gutter Slope (%)	N/A
N/A	Gutter Lip Ht (in)	N/A	N/A	Gutter X Slope (%)	N/A
N/A	Painted X Walk1?	No	N/A	Painted X Walk2?	No
	X Walk 1 Direction	To NE		X Walk 2 Direction	To NW
N/A	X Walk 1 Width (in)	N/A	N/A	X Walk 2 Width (in)	N/A
	X Walk 1 Slope (%)	0.2		X Walk 2 Slope (%)	6.3
	X Walk 1 X Slope (%)	5.5		X Walk 2 X Slope (%)	0.3

N/A	Ramp inside XWalk1?	N/A	N/A	Ramp inside XWalk2?	N/A
	Road Slope (%)	5.1	N/A	Clear Space?	N/A
	Road X Slope (%)	3.6	N/A	Clear Space to XWalk (in)	N/A
N/A	Any Obstructions?	N/A	N/A	Storm Grate/Utility Hazard?	N/A
	Obstruction Type			Storm Grate/Utility Type	
		N/A			N/A
			Yes	Surface Condition? (G/P)	Good

Remove & Replace Curb Ramp With Two New Directional Ramps or Equivalent.
