Access Compliance Report

Public Rights-of-Way

(Curb Ramps)

Intersection ID: 13121	Main Street: OLD_STEELE_CREEK_RD	Cross Street: PRIMROSE_AV	Location: NW
ADA ID: E562F17D29ED	Ramp Type: ParaDiag	Initial Pass/Fail: Fail	Overall Compliance: No
			Severity Score: 13.75

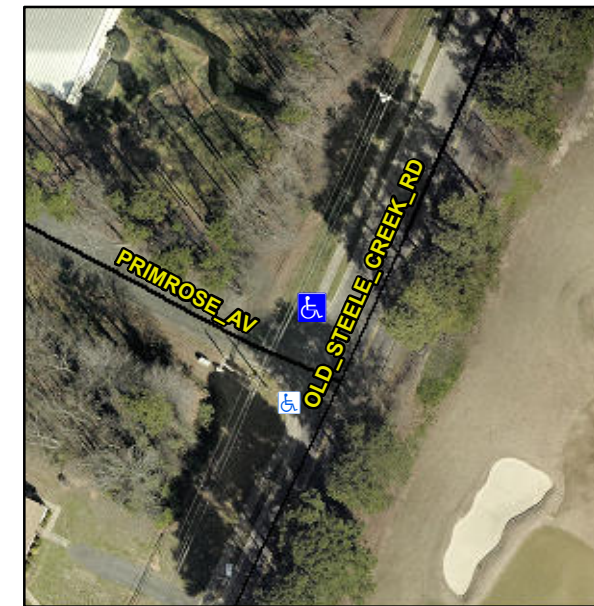
LT RP < 5%

R304.5.3, R304.3.2

Compliance	Description	Data	Compliance	Description	Data
N/A	Ramp Length LT (in)	36.0	N/A	Ramp Length RT (in)	42.0
Yes	Ramp Width LT (in)	107.0	Yes	Ramp Width RT (in)	107.0
Yes	Ramp Slope LT (%)	0.6	No	Ramp Slope RT (%)	10.6
No	Ramp XSlope LT (%)	2.4	Yes	Ramp XSlope RT (%)	1.0
N/A	Landing Length (in)	N/A	N/A	DWS Provided?	N/A
N/A	Landing Width (in)	N/A	N/A	DWS Contrast?	N/A
N/A	Landing Slope (%)	N/A	N/A	DWS Length (in)	N/A
N/A	Landing X Slope (%)	N/A	N/A	DWS Full Width?	N/A
N/A	Landing Curb? (Y/N)	N/A	N/A	DWS Offset (in)	N/A
N/A	Shared Landing?	N/A			
N/A	Gutter Ponding?	N/A	N/A	Gutter Slope (%)	N/A
N/A	Gutter Lip Ht (in)	N/A	N/A	Gutter X Slope (%)	N/A
N/A	Painted X Walk1?	No	N/A	Painted X Walk2?	No
	X Walk 1 Direction	To S		X Walk 2 Direction	To E
N/A	X Walk 1 Width (in)	N/A	N/A	X Walk 2 Width (in)	N/A
	X Walk 1 Slope (%)	1.4		X Walk 2 Slope (%)	3.0
	X Walk 1 X Slope (%)	5.4		X Walk 2 X Slope (%)	3.5
N/A	Ramp inside XWalk1?	N/A	N/A	Ramp inside XWalk2?	N/A

Road Slope (%)	3.3	N/A	Clear Space?	N/A
	Road X Slope (%)	3.6	N/A	Clear Space to XWalk (in)	N/A
N/A	Any Obstructions?	N/A	N/A	Storm Grate/Utility Hazard?	N/A
	Obstruction Type			Storm Grate/Utility Type	
		N/A			N/A
			Yes	Surface Condition? (G/P)	Good
			N/A	Curb Slope (%)	3.3

Remove & Replace Curb Ramp With Two New Directional Ramps or Equivalent.
