Intersection ID: 31243	Main Street: NEWFANE_RD	Cross Street: DAVID_COX_RD	Location:	SE
ADA ID: E56637708CB9	Ramp Type: Perp	Initial Pass/Fail: Fail	Overall Compliance: No	Severity Score: 21.25

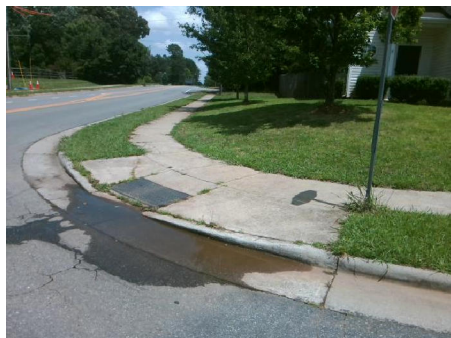
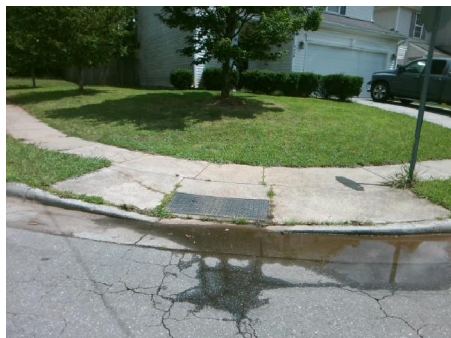
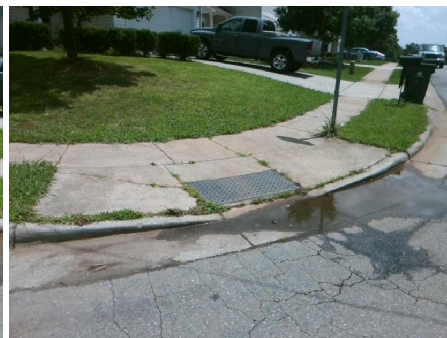
Possible Solutions:		Compliance	Description	Data	Compliance	Description	Data
	Remove & Replace Entire Ramp.		N/A	Ramp Length (in)	51.0	No	Ramp Slope (%)	8.6
			No	Ramp Width (in)	41.0	Yes	Ramp XSlope (%)	1.9
			N/A	Flare Type LT	N/A	N/A	Flare Type RT	N/A
			N/A	Flare Slope LT (%)	N/A	N/A	Flare Slope RT (%)	N/A
			N/A	Flare Traversable LT?	N/A	N/A	Flare Traversable RT?	N/A
			N/A	Landing Length (in)	N/A	N/A	DWS Provided?	N/A
			N/A	Landing Width (in)	N/A	N/A	DWS Contrast?	N/A
			N/A	Landing Slope (%)	N/A	N/A	DWS Length (in)	N/A
			N/A	Landing X Slope (%)	N/A	N/A	DWS Full Width?	N/A
Surveyor Notes:		N/A	N/A	Landing Curb? (Y/N)	N/A	N/A	DWS Offset (in)	N/A
PROW/ADA:		Not Found, R304.5.1, R304.2.2	N/A	Shared Landing?	N/A	N/A	Gutter Slope (%)	N/A
			N/A	Gutter Ponding?	N/A	N/A	Gutter X Slope (%)	N/A
			N/A	Gutter Lip Ht (in)	N/A	N/A	Gutter Slope (%)	N/A

N/A	Painted X Walk1?	No	N/A	Painted X Walk2?	N/A
				X Walk 1 Direction	To W		X Walk 2 Direction	N/A
			N/A	X Walk 1 Width (in)	N/A	N/A	X Walk 2 Width (in)	N/A
				X Walk 1 Slope (%)	1.8		X Walk 2 Slope (%)	N/A
				X Walk 1 X Slope (%)	0.7		X Walk 2 X Slope (%)	N/A
			N/A	Ramp inside XWalk1?	N/A	N/A	Ramp inside XWalk2?	N/A
				Road Slope (%)	N/A	N/A	Clear Space?	N/A
				Road X Slope (%)	N/A	N/A	Clear Space to XWalk (in)	N/A
			N/A	Any Obstructions?	N/A	N/A	Storm Grate/Utility Hazard?	N/A
				Obstruction Type			Storm Grate/Utility Type	
					N/A			N/A
						Yes	Surface Condition? (G/P)	Good
Street 1 Name	NEWFANE RD							
Stop Condition-Street 2	StopSign							
Street 2 Name	N/A							
Stop Condition-Street 1	N/A							
Total Cost:			\$	1850.00
