Access Compliance Report

Public Rights-of-Way

(Curb Ramps)

Intersection ID: 53147	Main Street: ACHIEVEMENT_LN	Cross Street: NEW_RENAISSANCE_WY	Location: NE
ADA ID: E571B5F0282B	Ramp Type: Perp	Initial Pass/Fail: Fail	Overall Compliance: No
Severity Score: 13.75			
Codes/Mitigation Info/Possible Solution		Field Measurements/Component Compliance

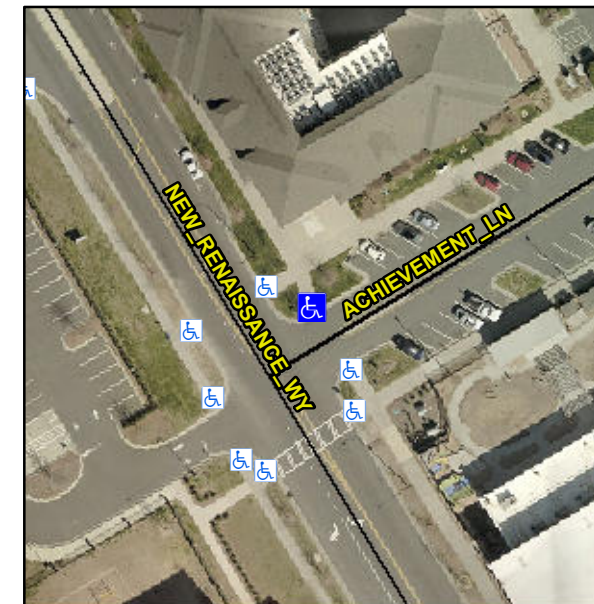
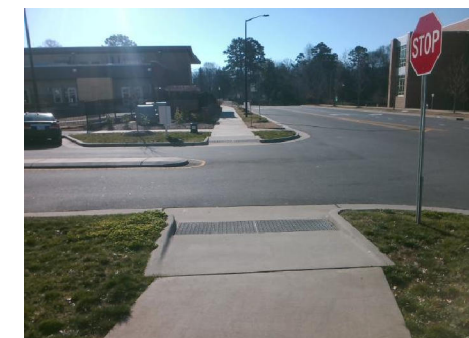
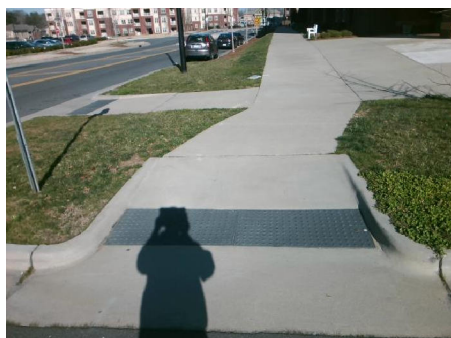
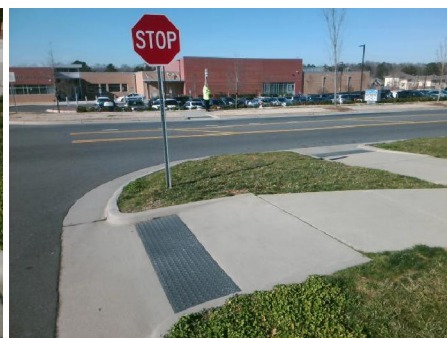
Compliance	Description	Data	Compliance	Description	Data
N/A	Ramp Length (in)	78.0	No	Ramp Slope (%)	8.5
Yes	Ramp Width (in)	96.0	No	Ramp XSlope (%)	4.5
N/A	Flare Type LT	N/A	N/A	Flare Type RT	N/A
N/A	Flare Slope LT (%)	N/A	N/A	Flare Slope RT (%)	N/A
N/A	Flare Traversable LT?	N/A	N/A	Flare Traversable RT?	N/A
N/A	Landing Length (in)	N/A	N/A	DWS Provided?	N/A
N/A	Landing Width (in)	N/A	N/A	DWS Contrast?	N/A
N/A	Landing Slope (%)	N/A	N/A	DWS Length (in)	N/A
N/A	Landing X Slope (%)	N/A	N/A	DWS Full Width?	N/A
N/A	Landing Curb? (Y/N)	N/A	N/A	DWS Offset (in)	N/A
N/A	Shared Landing?	N/A			
N/A	Gutter Ponding?	N/A	N/A	Gutter Slope (%)	N/A
N/A	Gutter Lip Ht (in)	N/A	N/A	Gutter X Slope (%)	N/A
N/A	Painted X Walk1?	No	N/A	Painted X Walk2?	N/A
	X Walk 1 Direction	To SE		X Walk 2 Direction	N/A
N/A	X Walk 1 Width (in)	N/A	N/A	X Walk 2 Width (in)	N/A
	X Walk 1 Slope (%)	2.3		X Walk 2 Slope (%)	N/A
	X Walk 1 X Slope (%)	3.3		X Walk 2 X Slope (%)	N/A

N/A	Ramp inside XWalk1?	N/A	N/A	Ramp inside XWalk2?	N/A
	Road Slope (%)	N/A	N/A	Clear Space?	N/A
	Road X Slope (%)	N/A	N/A	Clear Space to XWalk (in)	N/A
N/A	Any Obstructions?	N/A	N/A	Storm Grate/Utility Hazard?	N/A
	Obstruction Type			Storm Grate/Utility Type	
		N/A			N/A
			Yes	Surface Condition? (G/P)	Good

Possible Solutions:

Remove & Replace Entire Ramp.
