# Access Compliance Report

## Public Rights-of-Way

### (Curb Ramps)

Intersection ID: 30574	Main Street: FLOWING_BROOK_CT	Cross Street: HAMILTON_GREEN_DR	Location: NW
ADA ID: E576AD0E7FE6	Ramp Type: PerpDiag	Initial Pass/Fail: Pass	Overall Compliance: No
Severity Score: 10.25			
Codes/Mitigation Info/Possible Solution		Field Measurements/Component Compliance

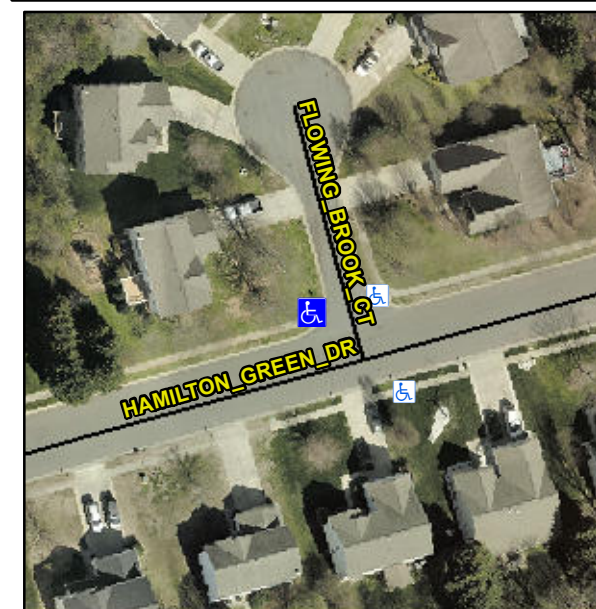
Compliance	Description	Data	Compliance	Description	Data
N/A	Ramp Length (in)	48.0	Yes	Ramp Slope (%)	7.5
Yes	Ramp Width (in)	48.0	No	Ramp XSlope (%)	3.3
N/A	Flare Type LT	Sloped	N/A	Flare Type RT	N/A
N/A	Flare Slope LT (%)	2.8	N/A	Flare Slope RT (%)	11.0
N/A	Flare Traversable LT?	No	N/A	Flare Traversable RT?	No
Yes	Landing Length (in)	48.0	No	DWS Provided?	No
Yes	Landing Width (in)	48.0	N/A	DWS Contrast?	No
No	Landing Slope (%)	4.0	N/A	DWS Length (in)	N/A
No	Landing X Slope (%)	4.1	N/A	DWS Full Width?	No
N/A	Landing Curb? (Y/N)	No	N/A	DWS Offset (in)	N/A
N/A	Shared Landing?	No			
Yes	Gutter Ponding?	No	Yes	Gutter Slope (%)	0.4
Yes	Gutter Lip Ht (in)	0.0	No	Gutter X Slope (%)	2.6
N/A	Painted X Walk1?	No	N/A	Painted X Walk2?	No
	X Walk 1 Direction	To S		X Walk 2 Direction	To E
N/A	X Walk 1 Width (in)	N/A	N/A	X Walk 2 Width (in)	N/A
	X Walk 1 Slope (%)	0.9		X Walk 2 Slope (%)	2.3
	X Walk 1 X Slope (%)	2.6		X Walk 2 X Slope (%)	1.5

N/A	Ramp inside XWalk1?	N/A	N/A	Ramp inside XWalk2?	N/A
	Road Slope (%)	4.0	N/A	Clear Space?	Yes
	Road X Slope (%)	5.1	N/A	Clear Space to XWalk (in)	N/A
Yes	Any Obstructions?	No	Yes	Storm Grate/Utility Hazard?	No
	Obstruction Type			Storm Grate/Utility Type	
		N/A			N/A
			Yes	Surface Condition? (G/P)	Good

**Remove & Replace Curb Ramp With Two New Directional Ramps or Equivalent. Remove & Replace Gutter.**
