Access Compliance Report

Public Rights-of-Way

(Curb Ramps)

| Intersection ID: 20967 | Main Street: SHARON_VIEW_RD | Cross Street: MOUNTAINBROOK_RD | Location: SW |

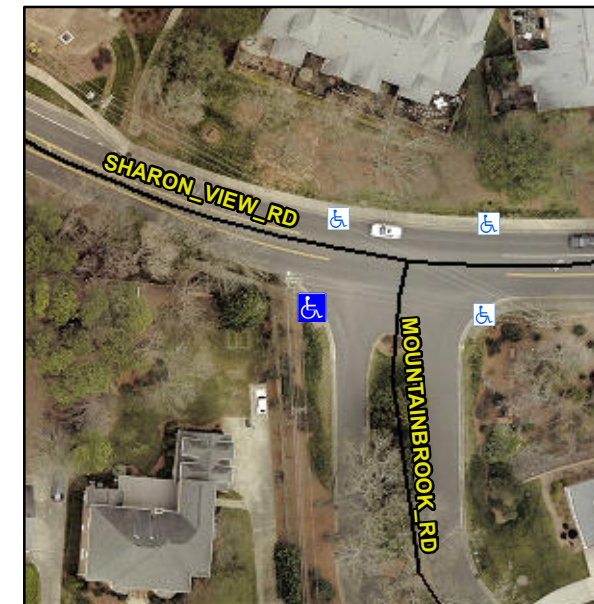
| ADA ID: E57CFCC169E1 | Ramp Type: ParaDiag | Initial Pass/Fail: Fail | Overall Compliance: No |
| | | Severity Score: 12.5 | |

LT RP < 5%

R304.3.2

| Compliance | Description | Data | Compliance | Description | Data |
|---|---|---|---|---|---|
| Yes | Ramp Slope LT (%) | 1.5 | No | Ramp Slope RT (%) | 10.0 |

Possible Solutions:

Remove & Replace Curb Ramp With Two New Directional Ramps or Equivalent.

Total Cost: \$ **3200.00**
