# Access Compliance Report

## Public Rights-of-Way

### (Curb Ramps)

Intersection ID: 22124	Main Street: CAMBRIDGE CRESCENT DR	Cross Street: ELLERY CRESCENT CR	Location: S
ADA ID: E59F461CC955	Ramp Type: PerpDiag	Initial Pass/Fail: Fail	Overall Compliance: No
Codes/Mitigation Info/Possible Solution		Field Measurements/Component Compliance	
Severity Score: 25

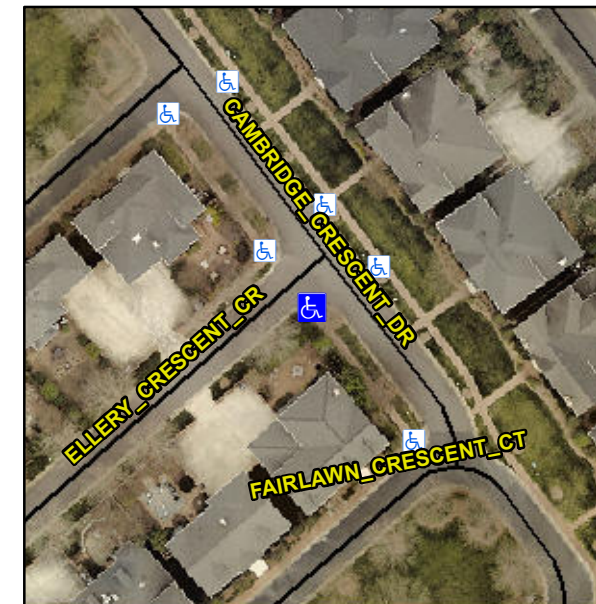
Compliance	Description	Data	Compliance	Description	Data
N/A	Ramp Length (in)	72.0	No	Ramp Slope (%)	14.9
Yes	Ramp Width (in)	48.0	Yes	Ramp XSlope (%)	1.0
N/A	Flare Type LT	N/A	N/A	Flare Type RT	N/A
N/A	Flare Slope LT (%)	N/A	N/A	Flare Slope RT (%)	N/A
N/A	Flare Traversable LT?	N/A	N/A	Flare Traversable RT?	N/A
N/A	Landing Length (in)	N/A	N/A	DWS Provided?	N/A
N/A	Landing Width (in)	N/A	N/A	DWS Contrast?	N/A
N/A	Landing Slope (%)	N/A	N/A	DWS Length (in)	N/A
N/A	Landing X Slope (%)	N/A	N/A	DWS Full Width?	N/A
N/A	Landing Curb? (Y/N)	N/A	N/A	DWS Offset (in)	N/A
N/A	Shared Landing?	N/A			
N/A	Gutter Ponding?	N/A	N/A	Gutter Slope (%)	N/A
N/A	Gutter Lip Ht (in)	N/A	N/A	Gutter X Slope (%)	N/A
N/A	Painted X Walk1?	No	N/A	Painted X Walk2?	No
	X Walk 1 Direction	To NE		X Walk 2 Direction	To NW
N/A	X Walk 1 Width (in)	N/A	N/A	X Walk 2 Width (in)	N/A
	X Walk 1 Slope (%)	0.2		X Walk 2 Slope (%)	3.3
	X Walk 1 X Slope (%)	3.2		X Walk 2 X Slope (%)	1.3

N/A	Ramp inside XWalk1?	N/A	N/A	Ramp inside XWalk2?	N/A
	Road Slope (%)	2.6	N/A	Clear Space?	N/A
	Road X Slope (%)	2.4	N/A	Clear Space to XWalk (in)	N/A
N/A	Any Obstructions?	N/A	N/A	Storm Grate/Utility Hazard?	N/A
	Obstruction Type			Storm Grate/Utility Type	
		N/A			N/A
			Yes	Surface Condition? (G/P)	Good

**Remove & Replace Curb Ramp With Two New Directional Ramps or Equivalent.**

**R304.2.2**

Total Cost: \$ 3200.00
