# Access Compliance Report

## Public Rights-of-Way

Intersection ID: 50008	Main Street: BERKELEY_PLACE_DR	Cross Street: SALERNO_DR	Location:	W
ADA ID: E5AF7917F8EB	Ramp Type: PerpDiag	Initial Pass/Fail: Fail	Overall Compliance: No	Severity Score: 25

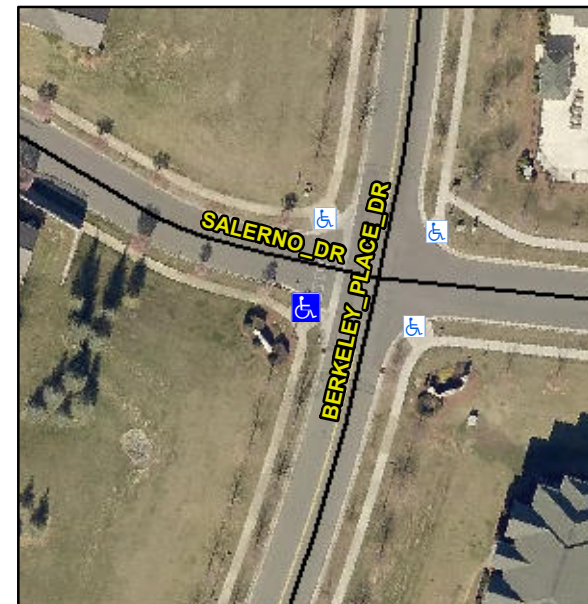
Compliance	Description	Data	Compliance	Description	Data
N/A	Ramp Length (in)	97.0	No	Ramp Slope (%)	18.0
Yes	Ramp Width (in)	52.0	Yes	Ramp XSlope (%)	1.0
N/A	Flare Type LT	N/A	N/A	Flare Type RT	N/A
N/A	Flare Slope LT (%)	N/A	N/A	Flare Slope RT (%)	N/A
N/A	Flare Traversable LT?	N/A	N/A	Flare Traversable RT?	N/A
N/A	Landing Length (in)	N/A	N/A	DWS Provided?	N/A
N/A	Landing Width (in)	N/A	N/A	DWS Contrast?	N/A
N/A	Landing Slope (%)	N/A	N/A	DWS Length (in)	N/A
N/A	Landing X Slope (%)	N/A	N/A	DWS Full Width?	N/A
N/A	Landing Curb? (Y/N)	N/A	N/A	DWS Offset (in)	N/A
N/A	Shared Landing?	N/A			
N/A	Gutter Ponding?	N/A	N/A	Gutter Slope (%)	N/A
N/A	Gutter Lip Ht (in)	N/A	N/A	Gutter X Slope (%)	N/A
N/A	Painted X Walk1?	No	N/A	Painted X Walk2?	Yes
	X Walk 1 Direction	To SE		X Walk 2 Direction	To NE
N/A	X Walk 1 Width (in)	N/A	N/A	X Walk 2 Width (in)	55.0
	X Walk 1 Slope (%)	0.8		X Walk 2 Slope (%)	1.7
	X Walk 1 X Slope (%)	0.7		X Walk 2 X Slope (%)	3.9

N/A	Ramp inside XWalk1?	N/A	N/A	Ramp inside XWalk2?	Yes
	Road Slope (%)	0.7	N/A	Clear Space?	N/A
	Road X Slope (%)	5.1	N/A	Clear Space to XWalk (in)	N/A
N/A	Any Obstructions?	N/A	N/A	Storm Grate/Utility Hazard?	N/A
	Obstruction Type			Storm Grate/Utility Type	
		N/A			N/A
			Yes	Surface Condition? (G/P)	Good

**Remove & Replace Curb Ramp With Two New Directional Ramps or Equivalent.**

**R304.2.2**
