# Access Compliance Report

## Public Rights-of-Way (Curb Ramps)

| Intersection ID: 52448 | Main Street: WOODWARD_AV | Cross Street: DOUBLE_OAKS_RD | Location: NW |
| ADA ID: E5B9EA092CBE | Ramp Type: Directional1 | Initial Pass/Fail: Pass | Overall Compliance: No |

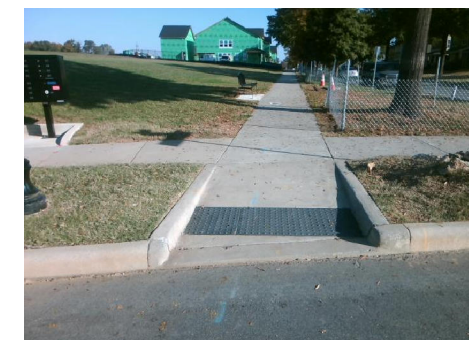
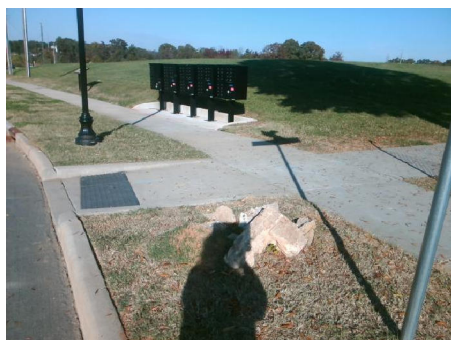
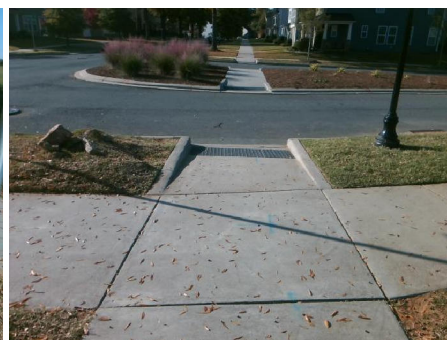
| Severity Score: 15 | | | |

**R304.2.2-Perp, R304.3.2-Para,  
R304.5.3, R302.7.2**

| Compliance | Description | Data | Compliance | Description | Data |
|---|---|---|---|---|---|
| Yes | Ramp Width (in) | 69.0 | No | Grade Break Slope (%) | 9.7 |
| Yes | Ramp Slope (%) | 8.3 | No | Grade Break XSlope (%) | 2.3 |
| No | Landing Slope (%) | 3.3 | Yes | DWS Length (in) | 24.0 |
| No | Gutter Lip Ht (in) | 1.0 | No | Gutter X Slope (%) | 2.8 |

**Remove & Replace Entire Ramp.  
Remove & Replace Gutter.**
