Access Compliance Report Public Rights-of-Way (Curb Ramps)

Intersection ID: 46183	Main Str	Cross Stre	et: NEE	DLEPOINT_RD	Location:	NW				
ADA ID: E5C97F5E26A1	Ramp Ty	/pe: PerpDiag	Initial Pas	al Pass/Fail: Pass Overall Compliance: No				o Severity Score:	0	
Codes/Mitigation Info/Possible Solution				Field Measurements/Component Compliance						
		Possible Solutions:	C	Compliance Description			Data Compliance Description			
11 - 31	aler the	Remove & Replace Curb Ramp W	ith N/	A Ram	p Length (in)	59.5	Yes	Ramp Slope (%)	6.7	
		Two New Directional Ramps or	Ye	s Ram	p Width (in)	48.0	Yes	Ramp XSlope (%)	1.6	
	and the second	Equivalent. Remove & Replace	N/	A Flare	e Type LT	Sloped	N/A	Flare Type RT	N/A	
	5 / / ·	Gutter.	N	A Flare	e Slope LT (%)	6.2	N/A	Flare Slope RT (%)	4.3	
	16 16		N	A Flare	e Traversable LT?	No	N/A	Flare Traversable RT?	No	
tion to the second s			N	b Land	ling Length (in)	47.0	Yes	DWS Provided?	Yes	
	the second second	Surveyor Notes:	Ye	s Land	ling Width (in)	48.0	Yes	DWS Contrast?	Yes

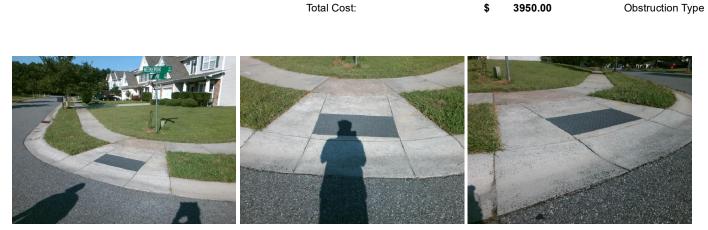
E.		N/A	N	b Land	ling Slope (%)	2.3	Yes	DWS Length (in)	24.0	
	G		Ye	s Land	ling X Slope (%)	1.0	Yes	DWS Full Width?	Yes	
AD /	the second		N		ling Curb? (Y/N)	No	No	DWS Offset (in)	4.0	
	the state of the s		N		red Landing?	No				
A BOL		PROW/ADA:	Ye	s Gutt	er Ponding?	No	Yes	Gutter Slope (%)	0.0	
SUL		Not Found, R304.2.1, R304.2.2-Pe	rp. Ye	s Gutt	er Lip Ht (in)	0.0	No	Gutter X Slope (%)	13.4	
		R304.3.2-Para, R305.2, R304.5.3	· •, N/	A Pain	ted X Walk1?	No	N/A	Painted X Walk2?	No	
	VE J DIE			X Wa	alk 1 Direction	To SE		X Walk 2 Direction	To E	
	1 1/		N	A XWa	alk 1 Width (in)	N/A	N/A	X Walk 2 Width (in)	N/A	
Street 1 Name	SWEETSPIRE RD	-		X Wa	alk 1 Slope (%)	2.1		X Walk 2 Slope (%)	2.6	
Stop Condition-Street 2	None				alk 1 X Slope (%)	0.4		X Walk 2 X Slope (%)	1.8	
Street 2 Name	NEEDLEPOINT RD		N		p inside XWalk1?	N/A	N/A	Ramp inside XWalk2?	N/A	
Stop Condition-Street 1	None				d Slope (%)	0.7	N/A	Clear Space?	Yes

d X Slope (%)	2.3	N/A	Clear Space to XWalk (in)	N/A	
			Ye		Obstructions?	No	Yes	Storm Grate/Utility Hazard?	No	
		Total Cost: \$ 39	50.00		truction Type			Storm Grate/Utility Type	-
