Access Compliance Report

Public Rights-of-Way

(Curb Ramps)

Intersection ID: 13871	Main Street: E_5TH_ST	Cross Street: HAWTHORNE_LN	Location: NE
ADA ID: E5CACB6E0173	Ramp Type: Directional1	Initial Pass/Fail: Fail	Overall Compliance: No
Severity Score: 12.5			
Codes/Mitigation Info/Possible Solution		Field Measurements/Component Compliance

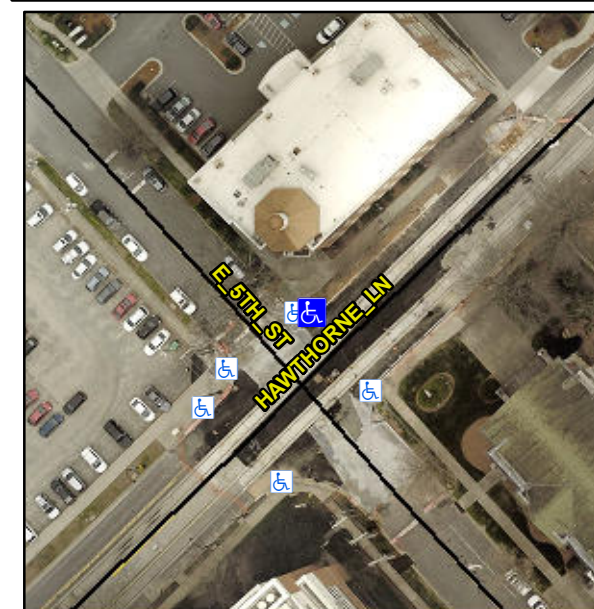
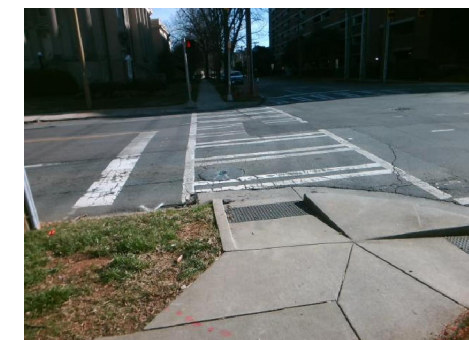
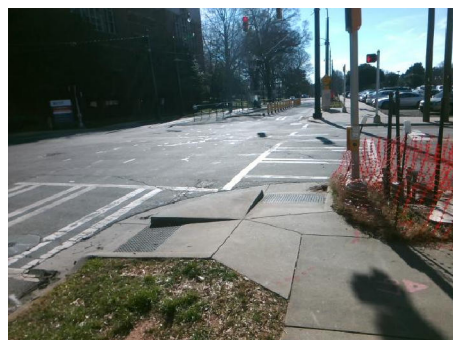
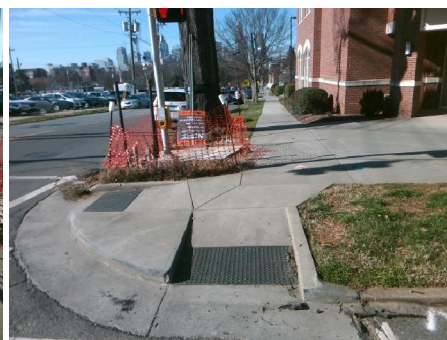
Compliance	Description	Data	Compliance	Description	Data
N/A	Ramp Length (in)	60.5	N/A	Grade Break?	N/A
Yes	Ramp Width (in)	48.5	N/A	Grade Break Slope (%)	0.0
No	Ramp Slope (%)	9.4	N/A	Grade Break XSlope (%)	0.0
Yes	Ramp XSlope (%)	1.3			
N/A	Flare Type LT	N/A	N/A	Flare Type RT	N/A
N/A	Flare Slope LT (%)	N/A	N/A	Flare Slope RT (%)	0.0
N/A	Flare Traversable LT?	N/A	N/A	Flare Traversable RT?	N/A
N/A	Landing Length (in)	0.0	N/A	DWS Provided?	N/A
N/A	Landing Width (in)	0.0	N/A	DWS Contrast?	N/A
N/A	Landing Slope (%)	0.0	N/A	DWS Length (in)	N/A
N/A	Landing X Slope (%)	0.0	N/A	DWS Full Width?	N/A
N/A	Landing Curb? (Y/N)	N/A	N/A	DWS Offset LT (in)	N/A
N/A	Shared Landing?	N/A	N/A	DWS Offset RT (in)	N/A
N/A	Gutter Ponding?	0.0	N/A	Gutter Slope (%)	N/A
N/A	Gutter Lip Ht (in)	0.0	N/A	Gutter X Slope (%)	N/A
N/A	Painted X Walk1?	Yes		Road Slope (%)	2.9
	X Walk 1 Direction	To SE		Road X Slope (%)	2.7
	X Walk 1 Width (in)	136.5		Clear Space?	N/A

X Walk 1 Slope (%)	2.9	N/A	Clear Space to XWalk (in)	N/A
	X Walk 1 X Slope (%)	2.7	N/A	Storm Grate/Utility Hazard?	N/A
N/A	Ramp inside XWalk1?	Yes		Storm Grate/Utility Type	
N/A	Any Obstructions?	N/A			N/A
	Obstruction Type		Yes	Surface Condition? (G/P)	Good
			N/A	Curb Slope (%)	5.6

Remove & Replace Entire Ramp.

R304.2.2
