Access Compliance Report

Public Rights-of-Way

(Curb Ramps)

Intersection ID: 43687	Main Street: PORTSTEWART_LN	Cross Street: TODDINGTON_LN	Location: NE
ADA ID: E5D530D081BC	Ramp Type: Perp	Initial Pass/Fail: Fail	Overall Compliance: No
Severity Score: 8.75			
Codes/Mitigation Info/Possible Solution		Field Measurements/Component Compliance

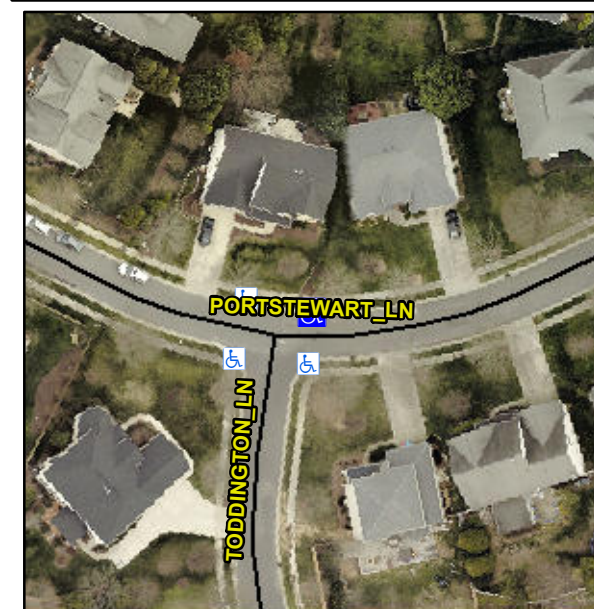
Not Found, R304.5.1

Compliance	Description	Data	Compliance	Description	Data
N/A	Ramp Length (in)	48.0	Yes	Ramp Slope (%)	5.2
No	Ramp Width (in)	46.5	Yes	Ramp XSlope (%)	1.1
N/A	Flare Type LT	N/A	N/A	Flare Type RT	N/A
N/A	Flare Slope LT (%)	N/A	N/A	Flare Slope RT (%)	N/A
N/A	Flare Traversable LT?	N/A	N/A	Flare Traversable RT?	N/A
N/A	Landing Length (in)	N/A	N/A	DWS Provided?	N/A
N/A	Landing Width (in)	N/A	N/A	DWS Contrast?	N/A
N/A	Landing Slope (%)	N/A	N/A	DWS Length (in)	N/A
N/A	Landing X Slope (%)	N/A	N/A	DWS Full Width?	N/A
N/A	Landing Curb? (Y/N)	N/A	N/A	DWS Offset (in)	N/A
N/A	Shared Landing?	N/A			
N/A	Gutter Ponding?	Yes	N/A	Gutter Slope (%)	N/A
N/A	Gutter Lip Ht (in)	N/A	N/A	Gutter X Slope (%)	N/A
N/A	Painted X Walk1?	No	N/A	Painted X Walk2?	N/A
	X Walk 1 Direction	To S		X Walk 2 Direction	N/A
N/A	X Walk 1 Width (in)	N/A	N/A	X Walk 2 Width (in)	N/A
	X Walk 1 Slope (%)	1.5		X Walk 2 Slope (%)	N/A
	X Walk 1 X Slope (%)	1.6		X Walk 2 X Slope (%)	N/A

N/A	Ramp inside XWalk1?	N/A	N/A	Ramp inside XWalk2?	N/A
	Road Slope (%)	N/A	N/A	Clear Space?	N/A
	Road X Slope (%)	N/A	N/A	Clear Space to XWalk (in)	N/A
N/A	Any Obstructions?	N/A	N/A	Storm Grate/Utility Hazard?	N/A
	Obstruction Type			Storm Grate/Utility Type	
		N/A			N/A
		Yes		Surface Condition? (G/P)	Good

Possible Solutions:

Remove & Replace Entire Ramp.
