Access Compliance Report

Public Rights-of-Way

(Curb Ramps)

Intersection ID: 53882	Main Street: PAW CLUB DR	Cross Street: PAW VILLAGE RD	Location: E
ADA ID: E5DE8E0C9C43	Ramp Type: PerpDiag	Initial Pass/Fail: Fail	Overall Compliance: No
Codes/Mitigation Info/Possible Solution		Field Measurements/Component Compliance	
Severity Score: 33.75

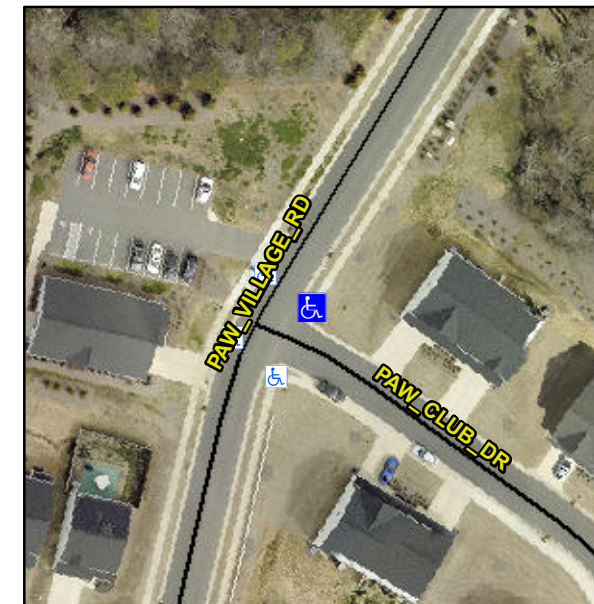
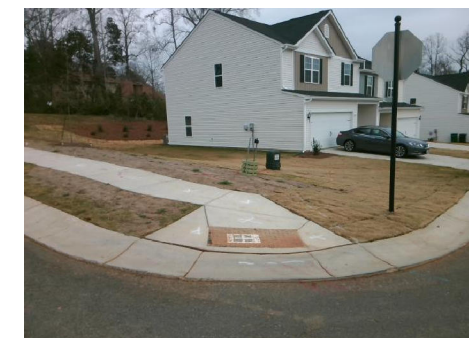
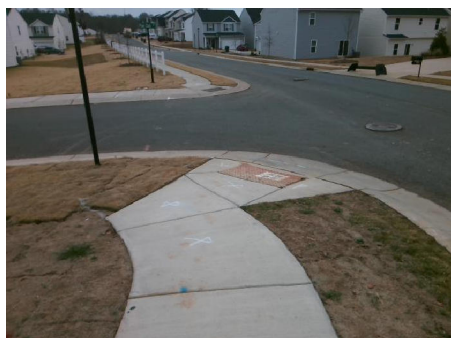
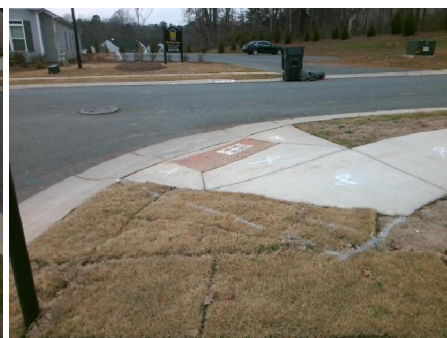
Not Found, R304.5.1, R304.5.3

Compliance	Description	Data	Compliance	Description	Data
N/A	Ramp Length (in)	49.0	Yes	Ramp Slope (%)	7.3
No	Ramp Width (in)	47.5	No	Ramp XSlope (%)	12.0
N/A	Flare Type LT	N/A	N/A	Flare Type RT	N/A
N/A	Flare Slope LT (%)	N/A	N/A	Flare Slope RT (%)	N/A
N/A	Flare Traversable LT?	N/A	N/A	Flare Traversable RT?	N/A
N/A	Landing Length (in)	N/A	N/A	DWS Provided?	N/A
N/A	Landing Width (in)	N/A	N/A	DWS Contrast?	N/A
N/A	Landing Slope (%)	N/A	N/A	DWS Length (in)	N/A
N/A	Landing X Slope (%)	N/A	N/A	DWS Full Width?	N/A
N/A	Landing Curb? (Y/N)	N/A	N/A	DWS Offset (in)	N/A
N/A	Shared Landing?	N/A			
N/A	Gutter Ponding?	N/A	N/A	Gutter Slope (%)	N/A
N/A	Gutter Lip Ht (in)	N/A	N/A	Gutter X Slope (%)	N/A
N/A	Painted X Walk1?	No	N/A	Painted X Walk2?	No
	X Walk 1 Direction	To NW		X Walk 2 Direction	To SW
N/A	X Walk 1 Width (in)	N/A	N/A	X Walk 2 Width (in)	N/A
	X Walk 1 Slope (%)	5.7		X Walk 2 Slope (%)	3.4
	X Walk 1 X Slope (%)	6.1		X Walk 2 X Slope (%)	6.1

N/A	Ramp inside XWalk1?	N/A	N/A	Ramp inside XWalk2?	N/A
	Road Slope (%)	6.7	N/A	Clear Space?	N/A
	Road X Slope (%)	3.1	N/A	Clear Space to XWalk (in)	N/A
N/A	Any Obstructions?	N/A	N/A	Storm Grate/Utility Hazard?	N/A
	Obstruction Type			Storm Grate/Utility Type	
		N/A			N/A
			Yes	Surface Condition? (G/P)	Good

Remove & Replace Curb Ramp With Two New Directional Ramps or Equivalent.
