# Access Compliance Report

## Public Rights-of-Way

### (Curb Ramps)

| Intersection ID: 48792 | Main Street: WOODLAND_WATCH_CT | Cross Street: COMMUNITY_HOUSE_RD | Location: SW |

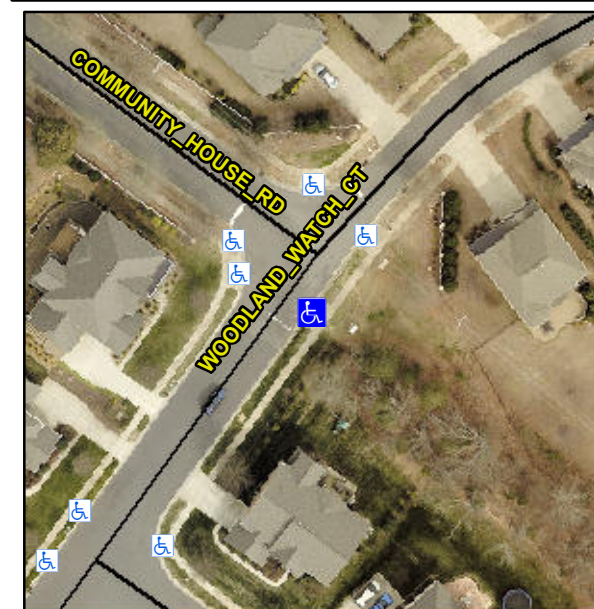
| ADA ID: E5E9A9F2D48B | Ramp Type: Perp | Initial Pass/Fail: Fail | Overall Compliance: No |

**Not Found, R304.2.2, R304.5.3**

| Compliance | Description | Data | Compliance | Description | Data |
|---|---|---|---|---|---|
| N/A | Ramp Length (in) | 73.0 | No | Ramp Slope (%) | 8.6 |
| Yes | Ramp Width (in) | 48.0 | No | Ramp XSlope (%) | 6.4 |

**Remove & Replace Entire Ramp.**

Total Cost: \$ 1850.00
