# Access Compliance Report

## Public Rights-of-Way

### (Curb Ramps)

Intersection ID: 14193	Main Street: E_5TH_ST	Cross Street: N_CASWELL_RD	Location: SE
ADA ID: E5F4D49FE419	Ramp Type: Perp	Initial Pass/Fail: Fail	Overall Compliance: No
Severity Score: 12.5			
Codes/Mitigation Info/Possible Solution		Field Measurements/Component Compliance

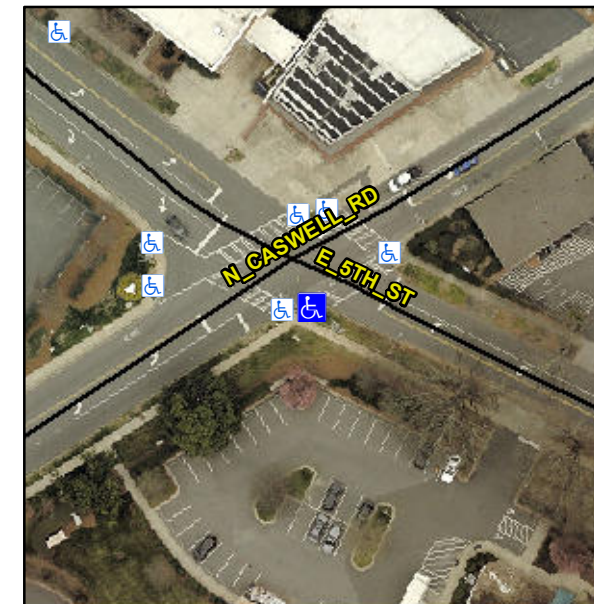
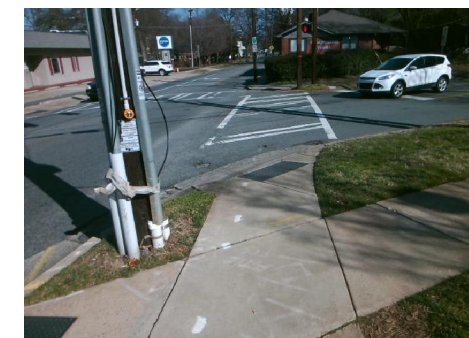
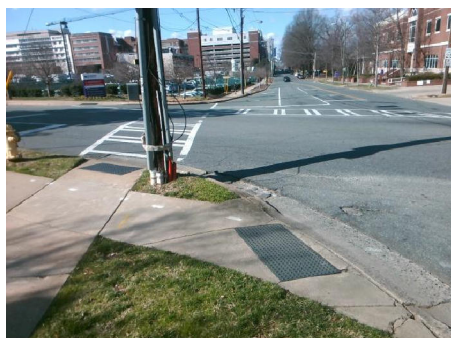
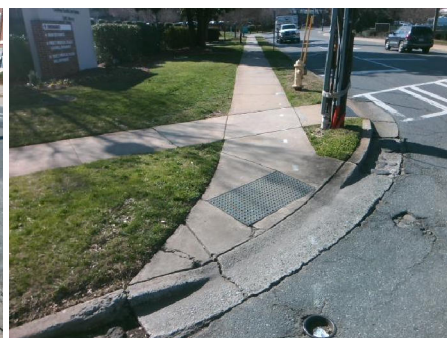
**Not Found, R304.2.2**

Compliance	Description	Data	Compliance	Description	Data
N/A	Ramp Length (in)	36.0	No	Ramp Slope (%)	11.9
Yes	Ramp Width (in)	48.0	Yes	Ramp XSlope (%)	1.1
N/A	Flare Type LT	N/A	N/A	Flare Type RT	N/A
N/A	Flare Slope LT (%)	N/A	N/A	Flare Slope RT (%)	N/A
N/A	Flare Traversable LT?	N/A	N/A	Flare Traversable RT?	N/A
N/A	Landing Length (in)	N/A	N/A	DWS Provided?	N/A
N/A	Landing Width (in)	N/A	N/A	DWS Contrast?	N/A
N/A	Landing Slope (%)	N/A	N/A	DWS Length (in)	N/A
N/A	Landing X Slope (%)	N/A	N/A	DWS Full Width?	N/A
N/A	Landing Curb? (Y/N)	N/A	N/A	DWS Offset (in)	N/A
N/A	Shared Landing?	N/A			
N/A	Gutter Ponding?	N/A	N/A	Gutter Slope (%)	N/A
N/A	Gutter Lip Ht (in)	N/A	N/A	Gutter X Slope (%)	N/A
N/A	Painted X Walk1?	Yes	N/A	Painted X Walk2?	N/A
	X Walk 1 Direction	To E		X Walk 2 Direction	N/A
N/A	X Walk 1 Width (in)	115.0	N/A	X Walk 2 Width (in)	N/A
	X Walk 1 Slope (%)	2.8		X Walk 2 Slope (%)	N/A
	X Walk 1 X Slope (%)	0.5		X Walk 2 X Slope (%)	N/A

N/A	Ramp inside XWalk1?	Yes	N/A	Ramp inside XWalk2?	N/A
	Road Slope (%)	N/A	N/A	Clear Space?	N/A
	Road X Slope (%)	N/A	N/A	Clear Space to XWalk (in)	N/A
N/A	Any Obstructions?	N/A	N/A	Storm Grate/Utility Hazard?	N/A
	Obstruction Type			Storm Grate/Utility Type	
		N/A			N/A
		Yes		Surface Condition? (G/P)	Good

Possible Solutions:

**Remove & Replace Entire Ramp.**
