Access Compliance Report

Public Rights-of-Way

(Curb Ramps)

Intersection ID: 14600	Main Street: DILWORTH_RD	Cross Street: DILWORTH_RD_EAST	Location: E
ADA ID: E607211036BA	Ramp Type: PerpDiag	Initial Pass/Fail: Fail	Overall Compliance: No
		Severity Score: 10

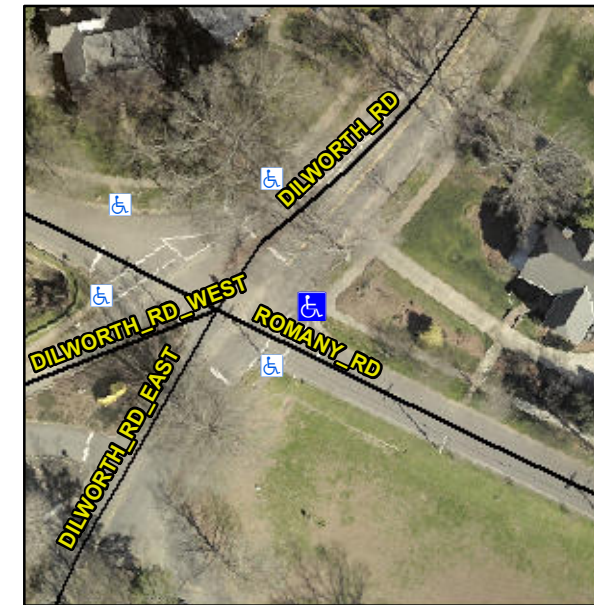
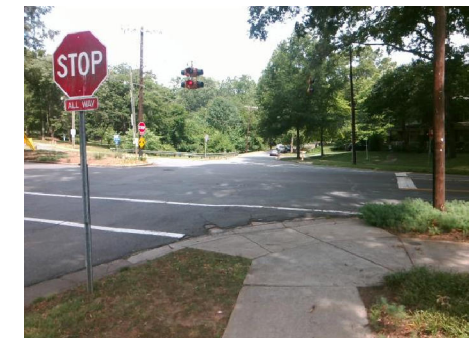
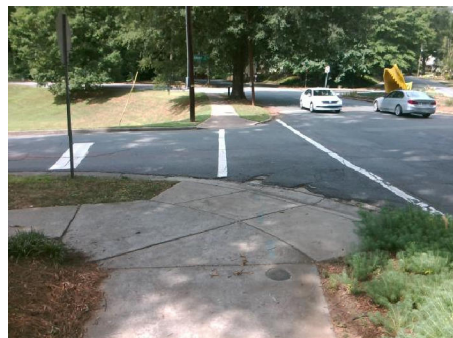
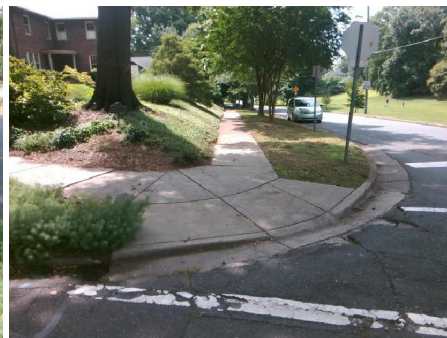
Not Found, R304.5.1, R304.5.3

Compliance	Description	Data	Compliance	Description	Data
N/A	Ramp Length (in)	96.0	Yes	Ramp Slope (%)	7.1
No	Ramp Width (in)	47.0	No	Ramp XSlope (%)	4.5
N/A	Flare Type LT	N/A	N/A	Flare Type RT	N/A
N/A	Flare Slope LT (%)	N/A	N/A	Flare Slope RT (%)	N/A
N/A	Flare Traversable LT?	N/A	N/A	Flare Traversable RT?	N/A
N/A	Landing Length (in)	N/A	N/A	DWS Provided?	N/A
N/A	Landing Width (in)	N/A	N/A	DWS Contrast?	N/A
N/A	Landing Slope (%)	N/A	N/A	DWS Length (in)	N/A
N/A	Landing X Slope (%)	N/A	N/A	DWS Full Width?	N/A
N/A	Landing Curb? (Y/N)	N/A	N/A	DWS Offset (in)	N/A
N/A	Shared Landing?	N/A			
N/A	Gutter Ponding?	N/A	N/A	Gutter Slope (%)	N/A
N/A	Gutter Lip Ht (in)	3.0	N/A	Gutter X Slope (%)	N/A
N/A	Painted X Walk1?	No	N/A	Painted X Walk2?	Yes
	X Walk 1 Direction	To N		X Walk 2 Direction	To SW
N/A	X Walk 1 Width (in)	N/A	N/A	X Walk 2 Width (in)	111.0
	X Walk 1 Slope (%)	2.1		X Walk 2 Slope (%)	4.2
	X Walk 1 X Slope (%)	1.4		X Walk 2 X Slope (%)	6.8

N/A	Ramp inside XWalk1?	N/A	N/A	Ramp inside XWalk2?	Yes
	Road Slope (%)	5.5	N/A	Clear Space?	N/A
	Road X Slope (%)	2.6	N/A	Clear Space to XWalk (in)	N/A
N/A	Any Obstructions?	N/A	N/A	Storm Grate/Utility Hazard?	N/A
	Obstruction Type			Storm Grate/Utility Type	
		N/A			N/A
		Yes		Surface Condition? (G/P)	Good

Remove & Replace Curb Ramp With Two New Directional Ramps or Equivalent.
