# Access Compliance Report

## Public Rights-of-Way

### (Curb Ramps)

Intersection ID: 13149	Main Street: CENTRAL_AV	Cross Street: THE_PLAZA	Location: SE
ADA ID: E60CECCB4EB0	Ramp Type: Perp	Initial Pass/Fail: Fail	Overall Compliance: No
Severity Score: 8.75			
Codes/Mitigation Info/Possible Solution		Field Measurements/Component Compliance

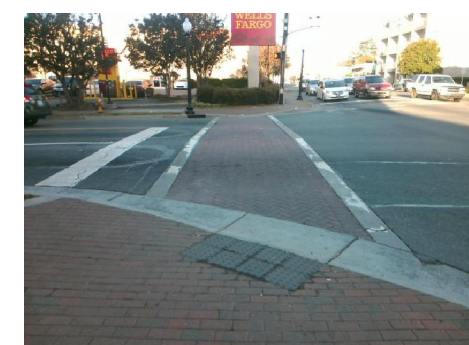
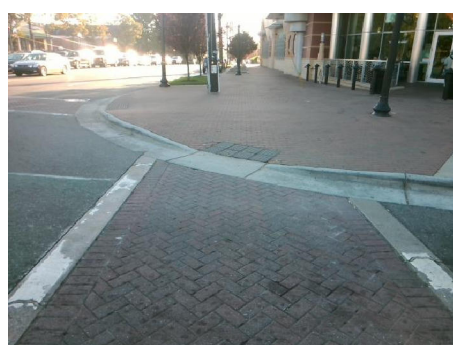
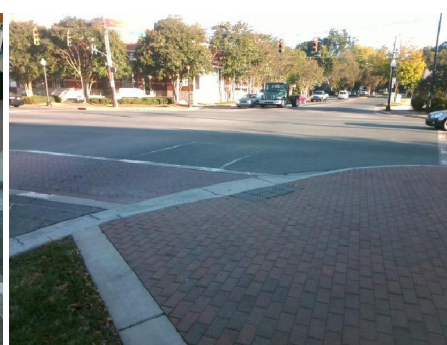
Compliance	Description	Data	Compliance	Description	Data
N/A	Ramp Length (in)	52.5	Yes	Ramp Slope (%)	6.9
No	Ramp Width (in)	45.5	Yes	Ramp XSlope (%)	0.3
N/A	Flare Type LT	N/A	N/A	Flare Type RT	N/A
N/A	Flare Slope LT (%)	N/A	N/A	Flare Slope RT (%)	N/A
N/A	Flare Traversable LT?	N/A	N/A	Flare Traversable RT?	N/A
N/A	Landing Length (in)	N/A	N/A	DWS Provided?	N/A
N/A	Landing Width (in)	N/A	N/A	DWS Contrast?	N/A
N/A	Landing Slope (%)	N/A	N/A	DWS Length (in)	N/A
N/A	Landing X Slope (%)	N/A	N/A	DWS Full Width?	N/A
N/A	Landing Curb? (Y/N)	N/A	N/A	DWS Offset (in)	N/A
N/A	Shared Landing?	N/A			
N/A	Gutter Ponding?	N/A	N/A	Gutter Slope (%)	N/A
N/A	Gutter Lip Ht (in)	N/A	N/A	Gutter X Slope (%)	N/A
N/A	Painted X Walk1?	Yes	N/A	Painted X Walk2?	N/A
	X Walk 1 Direction	To W		X Walk 2 Direction	N/A
N/A	X Walk 1 Width (in)	96.0	N/A	X Walk 2 Width (in)	N/A
	X Walk 1 Slope (%)	1.6		X Walk 2 Slope (%)	N/A
	X Walk 1 X Slope (%)	2.8		X Walk 2 X Slope (%)	N/A

N/A	Ramp inside XWalk1?	Yes	N/A	Ramp inside XWalk2?	N/A
	Road Slope (%)	N/A	N/A	Clear Space?	N/A
	Road X Slope (%)	N/A	N/A	Clear Space to XWalk (in)	N/A
N/A	Any Obstructions?	N/A	N/A	Storm Grate/Utility Hazard?	N/A
	Obstruction Type			Storm Grate/Utility Type	
		N/A			N/A
		Yes		Surface Condition? (G/P)	Good

Possible Solutions:

**Remove & Replace Entire Ramp.**
