Access Compliance Report Public Rights-of-Way (Curb Ramps)

Intersection ID: 9848 Main Street: THE_PLAZA Cross Street: WILANN_DR Location: NE **Overall Compliance: No** ADA ID: E615E4D535F7 Ramp Type: Perp Initial Pass/Fail: Fail **Severity Score:** 12.5

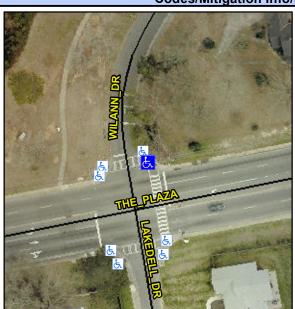
Field Measurements/Component Compliance								
Compl	iance Description	Data	Compl	liance	Description	Data		
N/A	Ramp Length (in)	59.0	No	Ramp	Slope (%)	11.7		
Yes	Ramp Width (in)	48.0	Yes	Ramp	XSlope (%)	1.1		
N/A	Flare Type LT	N/A	N/A	Flare	Type RT	N/A		
N/A	Flare Slope LT (%)	N/A	N/A	Flare	Slope RT (%)	N/A		
N/A	Flare Traversable LT?	N/A	N/A	Flare	Traversable RT?	N/A		
N/A	Landing Length (in)	N/A	N/A	DWS	Provided?	N/A		
N/A	Landing Width (in)	N/A	N/A	DWS	Contrast?	N/A		
N/A	Landing Slope (%)	N/A	N/A	DWS	Length (in)	N/A		
N/A	Landing X Slope (%)	N/A	N/A	DWS	Full Width?	N/A		
N/A	Landing Curb? (Y/N)	N/A	N/A	DWS	Offset (in)	N/A		
N/A	Shared Landing?	N/A						
N/A	Gutter Ponding?	N/A	N/A	Gutte	r Slope (%)	N/A		
N/A	Gutter Lip Ht (in)	1.0	N/A	Gutte	r X Slope (%)	N/A		
N/A	Painted X Walk1?	Yes	N/A	Paint	ed X Walk2?	N/A		
	X Walk 1 Direction	To S		X Wa	lk 2 Direction	N/A		
N/A	X Walk 1 Width (in)	104.5	N/A	X Wa	lk 2 Width (in)	N/A

000:0:0	
Possible Solutions:	Com
Remove & Replace Entire Ramp.	N/A
	Yes
	N/A
	N/A
	N/A
	N/A
Surveyor Notes:	N/A
N/A	N/A
	N/A
	N/A
	N/A
PROW/ADA:	N/A
Not Found, R304.2.2	N/A
	N/A
	N/A
	N/A
