Access Compliance Report

Public Rights-of-Way

(Curb Ramps)

Intersection ID: 16141	Main Street: N_WENDOVER_RD	Cross Street: LATROBE_DR	Location: NW
ADA ID: E617FBC5B99A	Ramp Type: Perp	Initial Pass/Fail: Fail	Overall Compliance: No
			Severity Score: 26.25

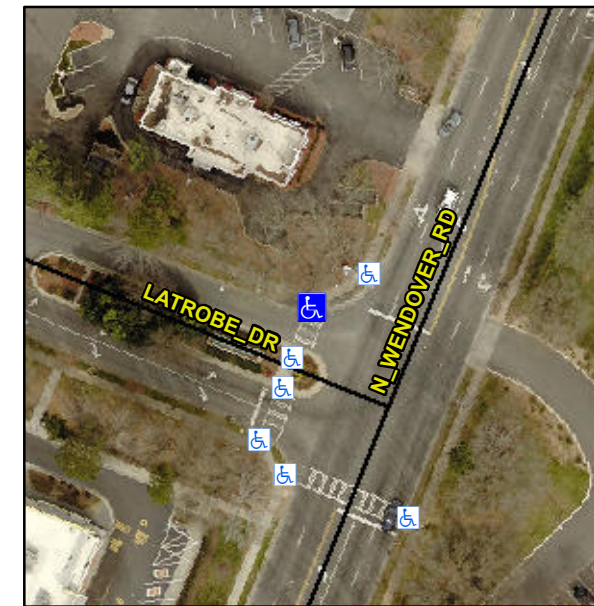
Not Found, R304.2.2, R304.5.3

Compliance	Description	Data	Compliance	Description	Data
N/A	Ramp Length (in)	50.0	No	Ramp Slope (%)	13.5
Yes	Ramp Width (in)	48.0	No	Ramp XSlope (%)	3.5
N/A	Flare Type LT	N/A	N/A	Flare Type RT	N/A
N/A	Flare Slope LT (%)	N/A	N/A	Flare Slope RT (%)	N/A
N/A	Flare Traversable LT?	N/A	N/A	Flare Traversable RT?	N/A
N/A	Landing Length (in)	N/A	N/A	DWS Provided?	N/A
N/A	Landing Width (in)	N/A	N/A	DWS Contrast?	N/A
N/A	Landing Slope (%)	N/A	N/A	DWS Length (in)	N/A
N/A	Landing X Slope (%)	N/A	N/A	DWS Full Width?	N/A
N/A	Landing Curb? (Y/N)	N/A	N/A	DWS Offset (in)	N/A
N/A	Shared Landing?	N/A			
N/A	Gutter Ponding?	N/A	N/A	Gutter Slope (%)	N/A
N/A	Gutter Lip Ht (in)	N/A	N/A	Gutter X Slope (%)	N/A
N/A	Painted X Walk1?	Yes	N/A	Painted X Walk2?	N/A
	X Walk 1 Direction	To SW		X Walk 2 Direction	N/A
N/A	X Walk 1 Width (in)	111.0	N/A	X Walk 2 Width (in)	N/A
	X Walk 1 Slope (%)	5.2		X Walk 2 Slope (%)	N/A
	X Walk 1 X Slope (%)	3.2		X Walk 2 X Slope (%)	N/A

N/A	Ramp inside XWalk1?	Yes	N/A	Ramp inside XWalk2?	N/A
	Road Slope (%)	N/A	N/A	Clear Space?	N/A
	Road X Slope (%)	N/A	N/A	Clear Space to XWalk (in)	N/A
N/A	Any Obstructions?	N/A	N/A	Storm Grate/Utility Hazard?	N/A
	Obstruction Type			Storm Grate/Utility Type	
		N/A			N/A
			Yes	Surface Condition? (G/P)	Good

Possible Solutions:

Remove & Replace Entire Ramp.
