Intersection ID: 10456	Main Street: MORSON_ST	Cross Street: ROSE_ST	Location:	NW
ADA ID: E61E801641A2	Ramp Type: PerpDiag	Initial Pass/Fail: Fail	Overall Compliance: No	Severity Score: 8.75

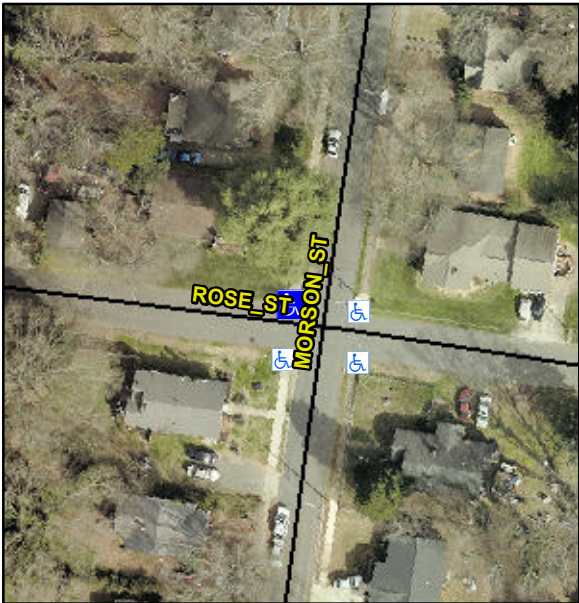
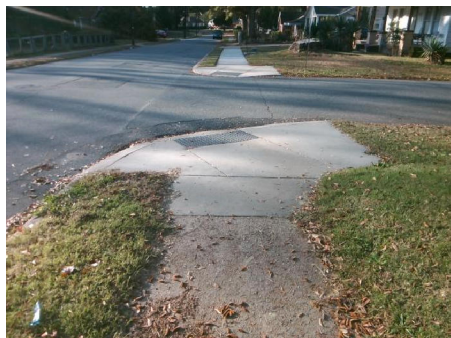
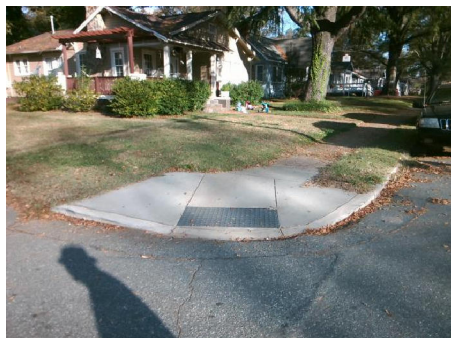
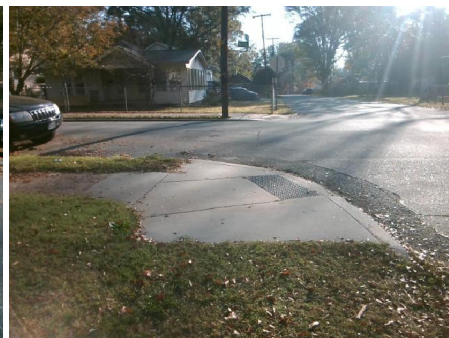
Possible Solutions:			Compliance	Description	Data	Compliance	Description	Data
	Remove & Replace Curb Ramp With Two New Directional Ramps or Equivalent.			N/A	Ramp Length (in)	75.0	Yes	Ramp Slope (%)	6.1
				No	Ramp Width (in)	47.5	Yes	Ramp XSlope (%)	2.0
				N/A	Flare Type LT	N/A	N/A	Flare Type RT	N/A
				N/A	Flare Slope LT (%)	N/A	N/A	Flare Slope RT (%)	N/A
				N/A	Flare Traversable LT?	N/A	N/A	Flare Traversable RT?	N/A
				N/A	Landing Length (in)	N/A	N/A	DWS Provided?	N/A
				N/A	Landing Width (in)	N/A	N/A	DWS Contrast?	N/A
				N/A	Landing Slope (%)	N/A	N/A	DWS Length (in)	N/A
				N/A	Landing X Slope (%)	N/A	N/A	DWS Full Width?	N/A
Surveyor Notes:			N/A	N/A	Landing Curb? (Y/N)	N/A	N/A	DWS Offset (in)	N/A
				N/A	Shared Landing?	N/A			
PROW/ADA:			Not Found, R304.5.1	N/A	Gutter Ponding?	N/A	N/A	Gutter Slope (%)	N/A

N/A	Gutter Lip Ht (in)	2.0	N/A	Gutter X Slope (%)	N/A
				N/A	Painted X Walk1?	No	N/A	Painted X Walk2?	No
					X Walk 1 Direction	To S		X Walk 2 Direction	To E
				N/A	X Walk 1 Width (in)	N/A	N/A	X Walk 2 Width (in)	N/A
					X Walk 1 Slope (%)	1.3		X Walk 2 Slope (%)	3.9
					X Walk 1 X Slope (%)	3.1		X Walk 2 X Slope (%)	1.8
				N/A	Ramp inside XWalk1?	N/A	N/A	Ramp inside XWalk2?	N/A
					Road Slope (%)	3.8	N/A	Clear Space?	N/A
					Road X Slope (%)	0.1	N/A	Clear Space to XWalk (in)	N/A
				N/A	Any Obstructions?	N/A	N/A	Storm Grate/Utility Hazard?	N/A
					Obstruction Type			Storm Grate/Utility Type	
						N/A			N/A
							Yes	Surface Condition? (G/P)	Good
Total Cost:			\$ 3200.00						
Street 1 Name			ROSE ST						
Stop Condition-Street 2			StopSign						
Street 2 Name			MORSON ST						
Stop Condition-Street 1			None
