Access Compliance Report

Public Rights-of-Way

(Curb Ramps)

Intersection ID: 2961	Main Street: GOLDENFIELD_DR	Cross Street: OLD_WILLOW_RD	Location: SE
ADA ID: E620600DA429	Ramp Type: Perp	Initial Pass/Fail: Fail	Overall Compliance: No
Severity Score: 22.5			
Codes/Mitigation Info/Possible Solution		Field Measurements/Component Compliance

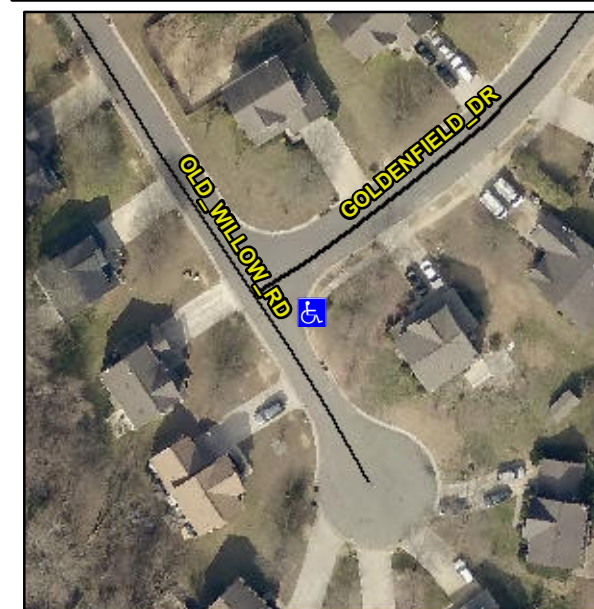
Not Found, R304.5.1, R304.2.2

Compliance	Description	Data	Compliance	Description	Data
N/A	Ramp Length (in)	48.0	No	Ramp Slope (%)	8.6
No	Ramp Width (in)	44.5	Yes	Ramp XSlope (%)	3.3
N/A	Flare Type LT	N/A	N/A	Flare Type RT	N/A
N/A	Flare Slope LT (%)	N/A	N/A	Flare Slope RT (%)	N/A
N/A	Flare Traversable LT?	N/A	N/A	Flare Traversable RT?	N/A
N/A	Landing Length (in)	N/A	N/A	DWS Provided?	N/A
N/A	Landing Width (in)	N/A	N/A	DWS Contrast?	N/A
N/A	Landing Slope (%)	N/A	N/A	DWS Length (in)	N/A
N/A	Landing X Slope (%)	N/A	N/A	DWS Full Width?	N/A
N/A	Landing Curb? (Y/N)	N/A	N/A	DWS Offset (in)	N/A
N/A	Shared Landing?	N/A			
N/A	Gutter Ponding?	N/A	N/A	Gutter Slope (%)	N/A
N/A	Gutter Lip Ht (in)	N/A	N/A	Gutter X Slope (%)	N/A
N/A	Painted X Walk1?	No	N/A	Painted X Walk2?	N/A
	X Walk 1 Direction	To W		X Walk 2 Direction	N/A
N/A	X Walk 1 Width (in)	N/A	N/A	X Walk 2 Width (in)	N/A
	X Walk 1 Slope (%)	1.8		X Walk 2 Slope (%)	N/A
	X Walk 1 X Slope (%)	4.6		X Walk 2 X Slope (%)	N/A

N/A	Ramp inside XWalk1?	N/A	N/A	Ramp inside XWalk2?	N/A
	Road Slope (%)	N/A	N/A	Clear Space?	N/A
	Road X Slope (%)	N/A	N/A	Clear Space to XWalk (in)	N/A
N/A	Any Obstructions?	N/A	N/A	Storm Grate/Utility Hazard?	N/A
	Obstruction Type			Storm Grate/Utility Type	
		N/A			N/A
			Yes	Surface Condition? (G/P)	Good

Remove & Replace Entire Ramp.
