# Access Compliance Report

## Public Rights-of-Way

### (Curb Ramps)

Intersection ID: 13614	Main Street: OLD_STEELE_CREEK_RD	Cross Street: WESTHAMPTON_DR	Location: SE
ADA ID: E622CF87F75F	Ramp Type: PerpDiag	Initial Pass/Fail: Fail	Overall Compliance: No
Severity Score: 1.25			
Codes/Mitigation Info/Possible Solution		Field Measurements/Component Compliance

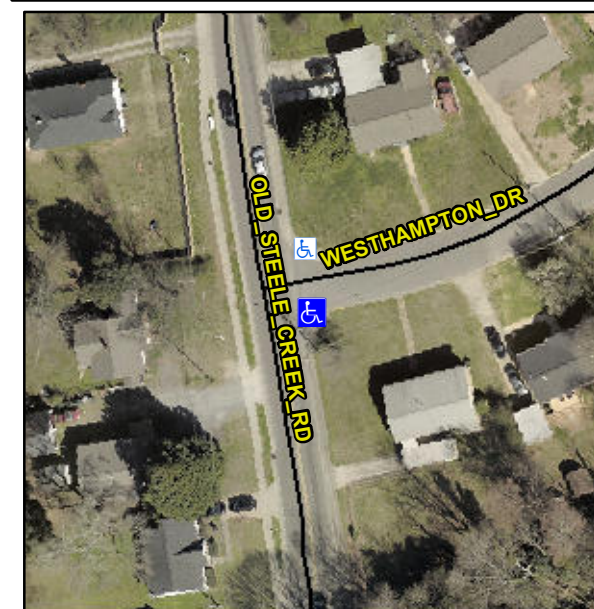
**Not Found, R304.5.3**

Compliance	Description	Data	Compliance	Description	Data
N/A	Ramp Length (in)	45.0	Yes	Ramp Slope (%)	5.2
Yes	Ramp Width (in)	48.0	No	Ramp XSlope (%)	2.8
N/A	Flare Type LT	N/A	N/A	Flare Type RT	N/A
N/A	Flare Slope LT (%)	N/A	N/A	Flare Slope RT (%)	N/A
N/A	Flare Traversable LT?	N/A	N/A	Flare Traversable RT?	N/A
N/A	Landing Length (in)	N/A	N/A	DWS Provided?	N/A
N/A	Landing Width (in)	N/A	N/A	DWS Contrast?	N/A
N/A	Landing Slope (%)	N/A	N/A	DWS Length (in)	N/A
N/A	Landing X Slope (%)	N/A	N/A	DWS Full Width?	N/A
N/A	Landing Curb? (Y/N)	N/A	N/A	DWS Offset (in)	N/A
N/A	Shared Landing?	N/A			
N/A	Gutter Ponding?	N/A	N/A	Gutter Slope (%)	N/A
N/A	Gutter Lip Ht (in)	N/A	N/A	Gutter X Slope (%)	N/A
N/A	Painted X Walk1?	No	N/A	Painted X Walk2?	No
	X Walk 1 Direction	To N		X Walk 2 Direction	To W
N/A	X Walk 1 Width (in)	N/A	N/A	X Walk 2 Width (in)	N/A
	X Walk 1 Slope (%)	2.9		X Walk 2 Slope (%)	7.5
	X Walk 1 X Slope (%)	6.6		X Walk 2 X Slope (%)	4.1

N/A	Ramp inside XWalk1?	N/A	N/A	Ramp inside XWalk2?	N/A
	Road Slope (%)	3.0	N/A	Clear Space?	N/A
	Road X Slope (%)	8.2	N/A	Clear Space to XWalk (in)	N/A
N/A	Any Obstructions?	N/A	N/A	Storm Grate/Utility Hazard?	N/A
	Obstruction Type			Storm Grate/Utility Type	
		N/A			N/A
			Yes	Surface Condition? (G/P)	Good

**Remove & Replace Curb Ramp With Two New Directional Ramps or Equivalent.**
