Access Compliance Report

Public Rights-of-Way

(Curb Ramps)

Intersection ID: 21868	Main Street: FOREST_POINT_BV	Cross Street: FOREST_POINT_CR	Location: NE
ADA ID: E625AE47B75C	Ramp Type: PerpDiag	Initial Pass/Fail: Fail	Overall Compliance: No
			Severity Score: 21.25

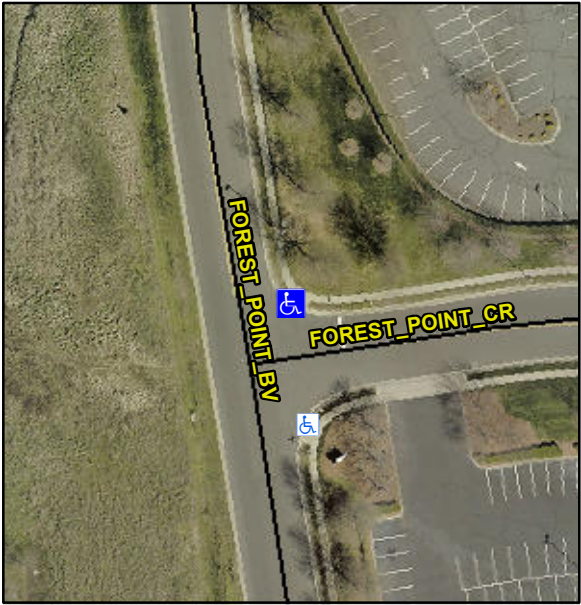
Possible Solutions:		Compliance	Description	Data
	Remove & Replace Curb Ramp With Two New Directional Ramps or Equivalent.		No	Ramp Length (in)	49.0
			No	Ramp Width (in)	43.0
			N/A	Flare Type LT	N/A
			N/A	Flare Slope LT (%)	N/A
			N/A	Flare Traversable LT?	N/A
			N/A	Landing Length (in)	N/A
			N/A	Landing Width (in)	N/A
			N/A	Landing Slope (%)	N/A
			N/A	Landing X Slope (%)	N/A
			N/A	Landing Curb? (Y/N)	N/A
			N/A	Shared Landing?	N/A
			N/A	Gutter Ponding?	N/A
			N/A	Gutter Lip Ht (in)	N/A
			No	Painted X Walk1?	N/A
				X Walk 1 Direction	To W
			N/A	X Walk 1 Width (in)	N/A
				X Walk 1 Slope (%)	1.1
				X Walk 1 X Slope (%)	0.0
			N/A	Ramp inside XWalk1?	N/A
<p>Surveyor Notes:</p> <p>N/A</p> <p>PROW/ADA:</p> <p>R304.5.1, R304.2.2</p>			N/A	Flare Type RT	N/A
			N/A	Flare Slope RT (%)	N/A
			N/A	Flare Traversable RT?	N/A

N/A	DWS Provided?	N/A
			N/A	DWS Contrast?	N/A
			N/A	DWS Length (in)	N/A
			N/A	DWS Full Width?	N/A
			N/A	DWS Offset (in)	N/A
			N/A	Gutter Slope (%)	N/A
			N/A	Gutter X Slope (%)	N/A
			No	Painted X Walk2?	N/A
				X Walk 2 Direction	To S
			N/A	X Walk 2 Width (in)	N/A
				X Walk 2 Slope (%)	0.3
				X Walk 2 X Slope (%)	0.4
			N/A	Ramp inside XWalk2?	N/A
			N/A	Clear Space?	N/A
			N/A	Clear Space to XWalk (in)	N/A
			N/A	Storm Grate/Utility Hazard?	N/A
				Storm Grate/Utility Type	N/A
<p>Total Cost:</p> <p>\$ 3200.00</p>			N/A		N/A
			Yes	Surface Condition? (G/P)	Good
