Intersection ID: 32090	Main Street: JERPOINT_ABBY_DR	Cross Street: RATHANGAN_DR	Location:	SW
ADA ID: E63395978FF3	Ramp Type: PerpDiag	Initial Pass/Fail: Fail	Overall Compliance: No	Severity Score: 33.75

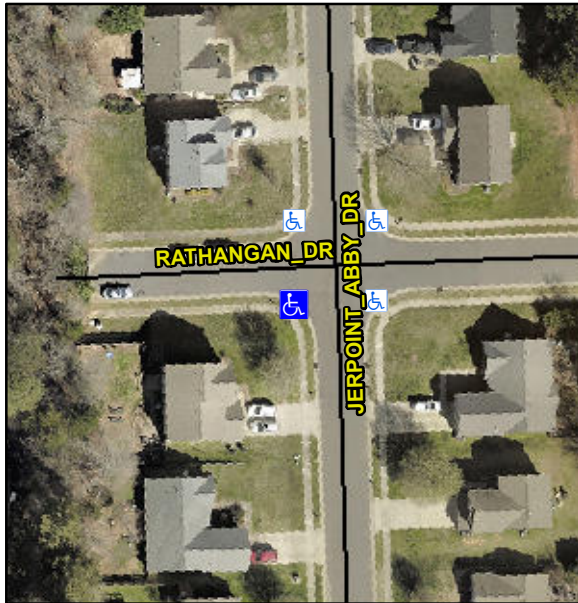
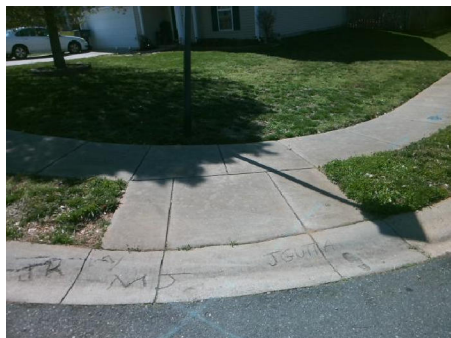
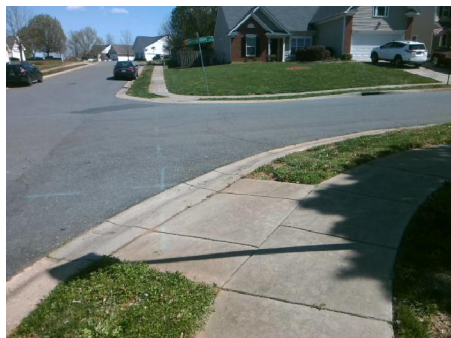
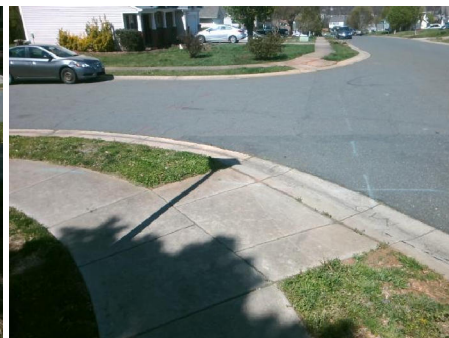
R304.5.1, R304.2.2, R304.5.3

Compliance	Description	Data	Compliance	Description	Data
N/A	Ramp Length (in)	51.5	No	Ramp Slope (%)	9.4
No	Ramp Width (in)	45.5	No	Ramp XSlope (%)	5.9
N/A	Flare Type LT	N/A	N/A	Flare Type RT	N/A
N/A	Flare Slope LT (%)	N/A	N/A	Flare Slope RT (%)	N/A
N/A	Flare Traversable LT?	N/A	N/A	Flare Traversable RT?	N/A
N/A	Landing Length (in)	N/A	N/A	DWS Provided?	N/A
N/A	Landing Width (in)	N/A	N/A	DWS Contrast?	N/A
N/A	Landing Slope (%)	N/A	N/A	DWS Length (in)	N/A
N/A	Landing X Slope (%)	N/A	N/A	DWS Full Width?	N/A
N/A	Landing Curb? (Y/N)	N/A	N/A	DWS Offset (in)	N/A
N/A	Shared Landing?	N/A			
N/A	Gutter Ponding?	N/A	N/A	Gutter Slope (%)	N/A
N/A	Gutter Lip Ht (in)	N/A	N/A	Gutter X Slope (%)	N/A
N/A	Painted X Walk1?	No	N/A	Painted X Walk2?	No
	X Walk 1 Direction	To N		X Walk 2 Direction	To E
N/A	X Walk 1 Width (in)	N/A	N/A	X Walk 2 Width (in)	N/A
	X Walk 1 Slope (%)	7.1		X Walk 2 Slope (%)	0.4
	X Walk 1 X Slope (%)	1.3		X Walk 2 X Slope (%)	5.8

N/A	Ramp inside XWalk1?	N/A	N/A	Ramp inside XWalk2?	N/A
	Road Slope (%)	5.4	N/A	Clear Space?	N/A
	Road X Slope (%)	5.3	N/A	Clear Space to XWalk (in)	N/A
N/A	Any Obstructions?	N/A	N/A	Storm Grate/Utility Hazard?	N/A
	Obstruction Type			Storm Grate/Utility Type	
		N/A			N/A
			Yes	Surface Condition? (G/P)	Good

Remove & Replace Curb Ramp With Two New Directional Ramps or Equivalent.
