# Access Compliance Report

## Public Rights-of-Way (Curb Ramps)

Intersection ID: 14828	Main Street: DWIGHTWARE_BV	Cross Street: SHACKLEFORD_TR	Location: NE
ADA ID: E63C9E618F47	Ramp Type: Directional1	Initial Pass/Fail: Fail	Overall Compliance: No
			Severity Score: 13.75

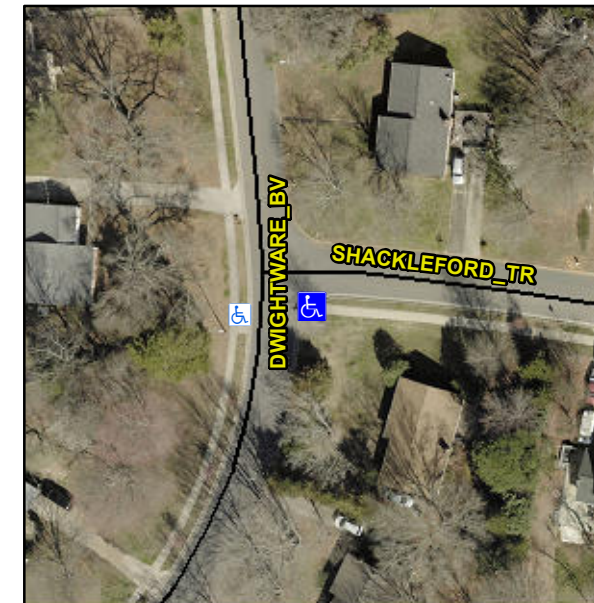
Compliance	Description	Data	Compliance	Description	Data
N/A	Ramp Length (in)	84.0	N/A	Grade Break?	N/A
Yes	Ramp Width (in)	48.0	N/A	Grade Break Slope (%)	0.0
No	Ramp Slope (%)	10.5	N/A	Grade Break XSlope (%)	0.0
Yes	Ramp XSlope (%)	4.0			
N/A	Flare Type LT	N/A	N/A	Flare Type RT	N/A
N/A	Flare Slope LT (%)	N/A	N/A	Flare Slope RT (%)	0.0
N/A	Flare Traversable LT?	N/A	N/A	Flare Traversable RT?	N/A
N/A	Landing Length (in)	0.0	N/A	DWS Provided?	N/A
N/A	Landing Width (in)	0.0	N/A	DWS Contrast?	N/A
N/A	Landing Slope (%)	0.0	N/A	DWS Length (in)	N/A
N/A	Landing X Slope (%)	0.0	N/A	DWS Full Width?	N/A
N/A	Landing Curb? (Y/N)	N/A	N/A	DWS Offset LT (in)	N/A
N/A	Shared Landing?	N/A	N/A	DWS Offset RT (in)	N/A
N/A	Gutter Ponding?	0.0	N/A	Gutter Slope (%)	N/A
N/A	Gutter Lip Ht (in)	0.0	N/A	Gutter X Slope (%)	N/A
N/A	Painted X Walk1?	No		Road Slope (%)	0.5
	X Walk 1 Direction	To W		Road X Slope (%)	4.3
	X Walk 1 Width (in)	N/A		Clear Space?	N/A

X Walk 1 Slope (%)	0.5	N/A	Clear Space to XWalk (in)	N/A
	X Walk 1 X Slope (%)	4.3	N/A	Storm Grate/Utility Hazard?	N/A
N/A	Ramp inside XWalk1?	N/A		Storm Grate/Utility Type	
N/A	Any Obstructions?	N/A			N/A
	Obstruction Type		Yes	Surface Condition? (G/P)	Good
			N/A	Curb Slope (%)	8.5

**Remove & Replace Entire Ramp.**
