# Access Compliance Report

## Public Rights-of-Way

### (Curb Ramps)

| Intersection ID: 29348 | Main Street: MISTY_LN | Cross Street: ELIZABETH_RD | Location: | N |

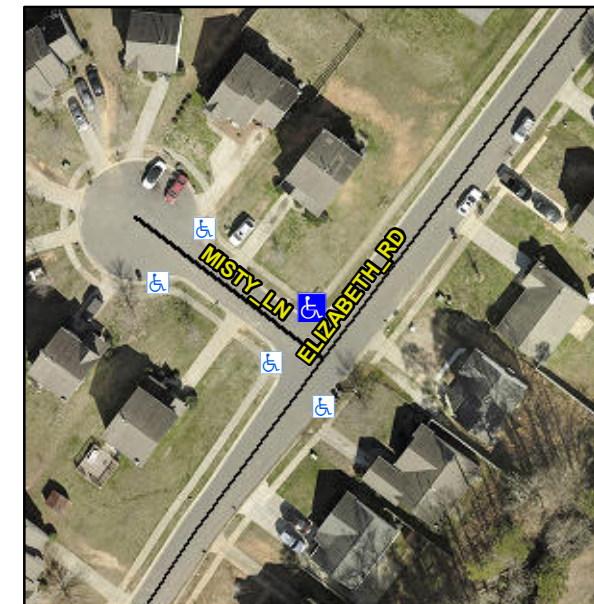
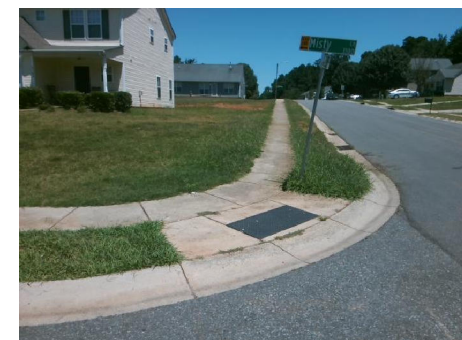
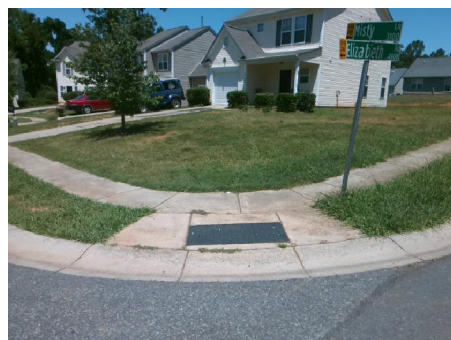
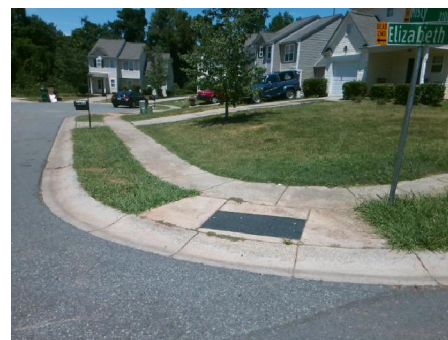
| ADA ID: E64DA2BC96B7 | Ramp Type: BlendTrans1 | Initial Pass/Fail: Fail | Overall Compliance: No | Severity Score: 10 |

**Not Found, R304.5.1, R304.5.3**

| Compliance | Description | Data | Compliance | Description | Data |
|---|---|---|---|---|---|
| No | Ramp Width (in) | 47.5 | No | BlendTrans XSlope (%) | 4.5 |

**Remove & Replace Curb Ramp With Two New Directional Ramps or Equivalent.**

Total Cost: \$ 3200.00
