# Access Compliance Report

## Public Rights-of-Way

### (Curb Ramps)

Intersection ID: 47415	Main Street: BRECKFIELD_CT	Cross Street: KIRKWYND_COMMONS_DR	Location: NE
ADA ID: E669660C9198	Ramp Type: BlendTrans1	Initial Pass/Fail: Fail	Overall Compliance: No
Severity Score: 8.75			
Codes/Mitigation Info/Possible Solution		Field Measurements/Component Compliance

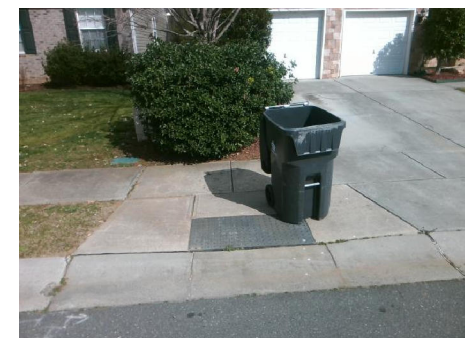
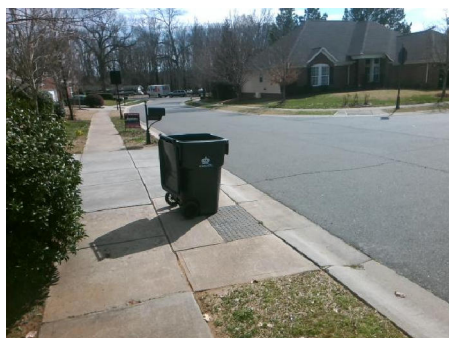
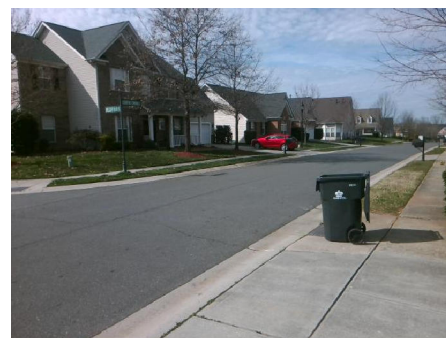
Compliance	Description	Data	Compliance	Description	Data
N/A	Ramp Length (in)	47.0	Yes	BlendTrans Slope (%)	3.1
No	Ramp Width (in)	47.0	Yes	BlendTrans XSlope (%)	0.6
N/A	Flare Type LT	N/A	N/A	Flare Type RT	N/A
N/A	Flare Slope LT (%)	N/A	N/A	Flare Slope RT (%)	N/A
N/A	Flare Traversable LT?	N/A	N/A	Flare Traversable RT?	N/A
N/A	Landing Length (in)	N/A	N/A	DWS Provided?	N/A
N/A	Landing Width (in)	N/A	N/A	DWS Contrast?	N/A
N/A	Landing Slope (%)	N/A	N/A	DWS Length (in)	N/A
N/A	Landing X Slope (%)	N/A	N/A	DWS Full Width?	N/A
N/A	Landing Curb? (Y/N)	N/A	N/A	DWS Offset (in)	N/A
N/A	Shared Landing?	N/A			
N/A	Gutter Ponding?	N/A	N/A	Gutter Slope (%)	N/A
N/A	Gutter Lip Ht (in)	N/A	N/A	Gutter X Slope (%)	N/A
N/A	Painted X Walk1?	No	N/A	Painted X Walk2?	N/A
	X Walk 1 Direction	To SW		X Walk 2 Direction	N/A
	X Walk 1 Width (in)	N/A		X Walk 2 Width (in)	N/A
	X Walk 1 Slope (%)	2.7		X Walk 2 Slope (%)	N/A
	X Walk 1 X Slope (%)	0.9		X Walk 2 X Slope (%)	N/A

N/A	Ramp inside XWalk1?	N/A	N/A	Ramp inside XWalk2?	N/A
	Road Slope (%)	0.9		Clear Space?	N/A
	Road X Slope (%)	2.7	N/A	Clear Space to XWalk (in)	N/A
N/A	Any Obstructions?	N/A	N/A	Storm Grate/Utility Hazard?	N/A
	Obstruction Type			Storm Grate/Utility Type	
		N/A			N/A
			Yes	Surface Condition? (G/P)	Good
			N/A	Curb Slope (%)	2.8

**Remove & Replace Curb Ramp With Two New Directional Ramps or Equivalent.**
