# Access Compliance Report

## Public Rights-of-Way

### (Curb Ramps)

Intersection ID: 23921	Main Street: LAMPMEADE_LN	Cross Street: PORTRUSH_LN	Location: SW
ADA ID: E66A7CFC0E56	Ramp Type: PerpDiag	Initial Pass/Fail: Fail	Overall Compliance: No
		Severity Score: 8.75

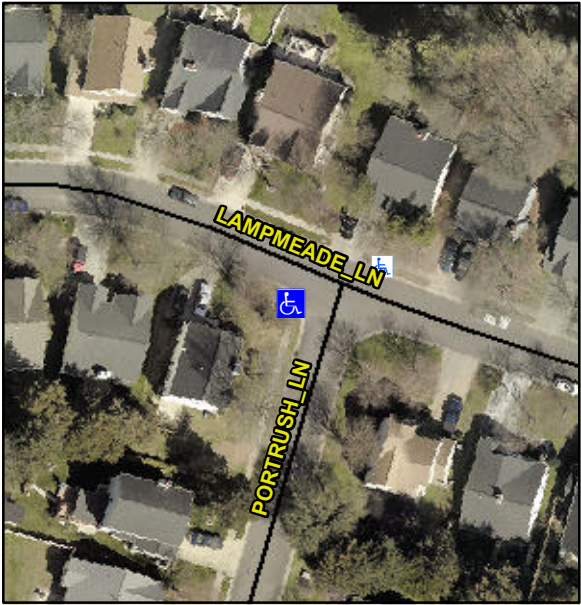
Possible Solutions:		<b>Compliance</b>	<b>Description</b>	<b>Data</b>	
	<b>Remove &amp; Replace Curb Ramp With Two New Directional Ramps or Equivalent.</b>		N/A	Ramp Length (in)	95.0	<b>Yes</b>
			No	Ramp Width (in)	47.0	<b>Yes</b>
			N/A	Flare Type LT	N/A	N/A
			N/A	Flare Slope LT (%)	N/A	N/A
			N/A	Flare Traversable LT?	N/A	N/A
			N/A	Landing Length (in)	N/A	N/A
			N/A	Landing Width (in)	N/A	N/A
			N/A	Landing Slope (%)	N/A	N/A
			N/A	Landing X Slope (%)	N/A	N/A
<p>Surveyor Notes:</p> <p><b>N/A</b></p> <p>PROW/ADA:</p> <p><b>Not Found, R304.5.1</b></p>			N/A	Flare Type RT	N/A	N/A
			N/A	Flare Slope RT (%)	N/A	N/A
			N/A	Flare Traversable RT?	N/A	N/A
			N/A	DWS Provided?	N/A	N/A
			N/A	DWS Contrast?	N/A	N/A
			N/A	DWS Length (in)	N/A	N/A
			N/A	DWS Full Width?	N/A	N/A
			N/A	DWS Offset (in)	N/A	N/A
			N/A	Gutter Ponding?	N/A	N/A

N/A	Gutter Lip Ht (in)	N/A	N/A
			N/A	Painted X Walk1?	No	N/A
				X Walk 1 Direction	To SE	
			N/A	X Walk 1 Width (in)	N/A	N/A
				X Walk 1 Slope (%)	0.5	
				X Walk 1 X Slope (%)	0.0	
			N/A	Ramp inside XWalk1?	N/A	N/A
				Road Slope (%)	1.0	N/A
				Road X Slope (%)	0.8	N/A
			N/A	Any Obstructions?	N/A	N/A
				Obstruction Type		
Total Cost: \$ 3200.00					N/A	N/A
					Yes	Surface Condition? (G/P) Good
