Access Compliance Report

Public Rights-of-Way

(Curb Ramps)

Intersection ID: 10015389	Main Street: CALDWELL_FOREST_DR	Cross Street: N/A	Location: E
ADA ID: E675355845C9	Ramp Type: PerpDiag	Initial Pass/Fail: Fail	Overall Compliance: No
			Severity Score: 13.75

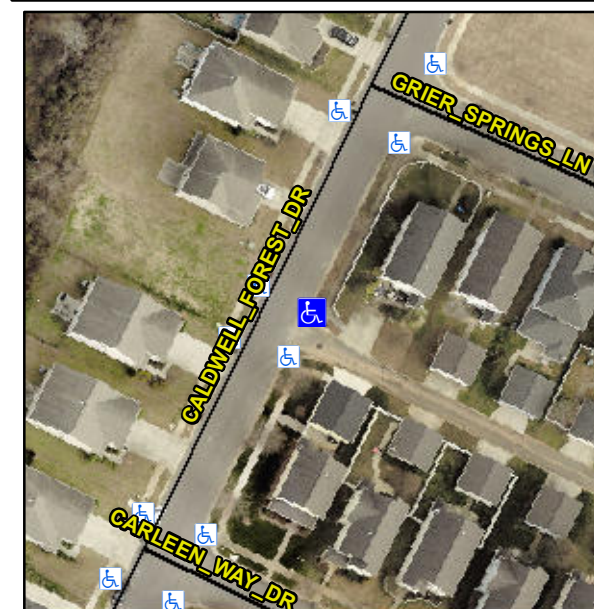
Not Found, R304.2.2, R304.5.3

Compliance	Description	Data	Compliance	Description	Data
N/A	Ramp Length (in)	46.5	No	Ramp Slope (%)	11.1
Yes	Ramp Width (in)	50.0	No	Ramp XSlope (%)	2.9
N/A	Flare Type LT	N/A	N/A	Flare Type RT	N/A
N/A	Flare Slope LT (%)	N/A	N/A	Flare Slope RT (%)	N/A
N/A	Flare Traversable LT?	N/A	N/A	Flare Traversable RT?	N/A
N/A	Landing Length (in)	N/A	N/A	DWS Provided?	N/A
N/A	Landing Width (in)	N/A	N/A	DWS Contrast?	N/A
N/A	Landing Slope (%)	N/A	N/A	DWS Length (in)	N/A
N/A	Landing X Slope (%)	N/A	N/A	DWS Full Width?	N/A
N/A	Landing Curb? (Y/N)	N/A	N/A	DWS Offset (in)	N/A
N/A	Shared Landing?	N/A			
N/A	Gutter Ponding?	N/A	N/A	Gutter Slope (%)	N/A
N/A	Gutter Lip Ht (in)	N/A	N/A	Gutter X Slope (%)	N/A
N/A	Painted X Walk1?	No	N/A	Painted X Walk2?	No
	X Walk 1 Direction	To W		X Walk 2 Direction	To S
N/A	X Walk 1 Width (in)	N/A	N/A	X Walk 2 Width (in)	N/A
	X Walk 1 Slope (%)	1.4		X Walk 2 Slope (%)	0.7
	X Walk 1 X Slope (%)	2.4		X Walk 2 X Slope (%)	1.3

N/A	Ramp inside XWalk1?	N/A	N/A	Ramp inside XWalk2?	N/A
	Road Slope (%)	0.8	N/A	Clear Space?	N/A
	Road X Slope (%)	0.0	N/A	Clear Space to XWalk (in)	N/A
N/A	Any Obstructions?	N/A	N/A	Storm Grate/Utility Hazard?	N/A
	Obstruction Type			Storm Grate/Utility Type	
		N/A			N/A
		Yes		Surface Condition? (G/P)	Good

Remove & Replace Curb Ramp With Two New Directional Ramps or Equivalent.
