Access Compliance Report

Public Rights-of-Way

(Curb Ramps)

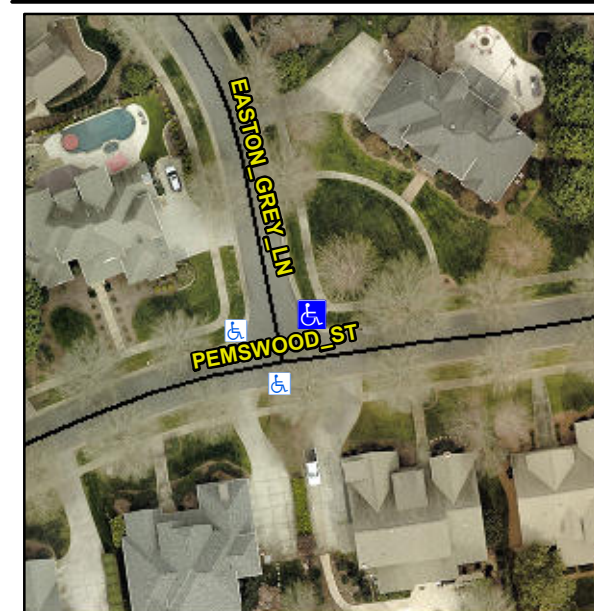
Intersection ID: 28277	Main Street: EASTON_GREY_LN	Cross Street: PEMSWOOD_ST	Location: NE
ADA ID: E67EBFABB27F	Ramp Type: BlendTrans2	Initial Pass/Fail: Fail	Overall Compliance: No
Codes/Mitigation Info/Possible Solution		Field Measurements/Component Compliance	
Severity Score: 8.75

CURB GAP 0.5

Not Found, R304.5.1

Compliance	Description	Data	Compliance	Description	Data
N/A	Ramp Length (in)	156.0	Yes	BlendTrans Slope (%)	3.0
No	Ramp Width (in)	38.0	Yes	BlendTrans XSlope (%)	1.7
N/A	Flare Type LT	N/A	N/A	Flare Type RT	N/A
N/A	Flare Slope LT (%)	N/A	N/A	Flare Slope RT (%)	N/A
N/A	Flare Traversable LT?	N/A	N/A	Flare Traversable RT?	N/A
N/A	Landing Length (in)	N/A	N/A	DWS Provided?	N/A
N/A	Landing Width (in)	N/A	N/A	DWS Contrast?	N/A
N/A	Landing Slope (%)	N/A	N/A	DWS Length (in)	N/A
N/A	Landing X Slope (%)	N/A	N/A	DWS Full Width?	N/A
N/A	Landing Curb? (Y/N)	N/A	N/A	DWS Offset (in)	N/A
N/A	Shared Landing?	N/A			
N/A	Gutter Ponding?	N/A	N/A	Gutter Slope (%)	N/A
N/A	Gutter Lip Ht (in)	N/A	N/A	Gutter X Slope (%)	N/A
N/A	Painted X Walk1?	No	N/A	Painted X Walk2?	No
	X Walk 1 Direction	To W		X Walk 2 Direction	To SE
	X Walk 1 Width (in)	N/A		X Walk 2 Width (in)	N/A
	X Walk 1 Slope (%)	2.8		X Walk 2 Slope (%)	4.2
	X Walk 1 X Slope (%)	3.7		X Walk 2 X Slope (%)	0.1

N/A	Ramp inside XWalk1?	N/A	N/A	Ramp inside XWalk2?	N/A
	Road Slope (%)	2.1		Clear Space?	N/A
	Road X Slope (%)	1.1	N/A	Clear Space to XWalk (in)	N/A
N/A	Any Obstructions?	N/A	N/A	Storm Grate/Utility Hazard?	N/A
	Obstruction Type			Storm Grate/Utility Type	
		N/A			N/A
			Yes	Surface Condition? (G/P)	Good
			No	Curb Slope (%)	9.6

Possible Solutions:

Remove & Replace Curb Ramp With Two New Directional Ramps or Equivalent.
