# Access Compliance Report

## Public Rights-of-Way

### (Curb Ramps)

Intersection ID: 18386	Main Street: E_W_T_HARRIS_BV	Cross Street: LAURA_DR	Location: NW
ADA ID: E683FD72C21F	Ramp Type: Perp	Initial Pass/Fail: Fail	Overall Compliance: No
Severity Score: 33.75			
Codes/Mitigation Info/Possible Solution		Field Measurements/Component Compliance

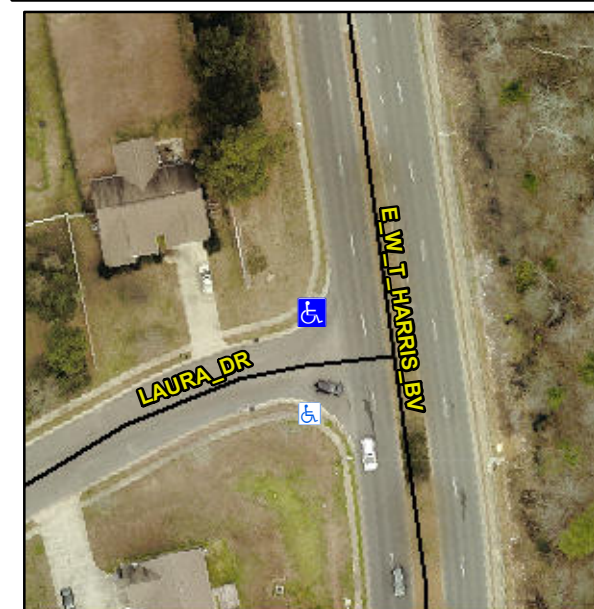
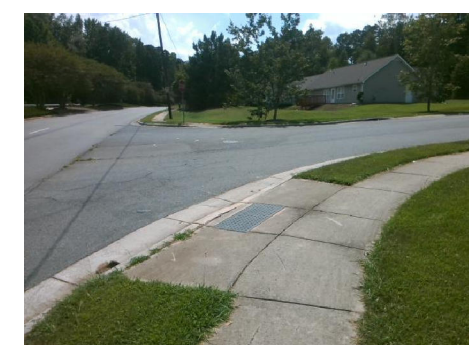
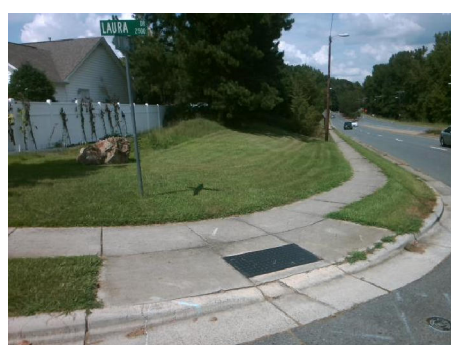
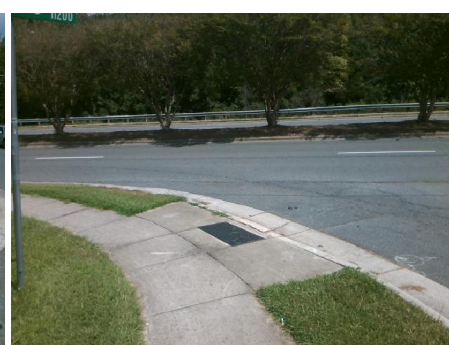
**Not Found, R304.5.1, R304.5.3**

Compliance	Description	Data	Compliance	Description	Data
N/A	Ramp Length (in)	47.0	Yes	Ramp Slope (%)	5.2
No	Ramp Width (in)	42.0	No	Ramp XSlope (%)	8.8
N/A	Flare Type LT	N/A	N/A	Flare Type RT	N/A
N/A	Flare Slope LT (%)	N/A	N/A	Flare Slope RT (%)	N/A
N/A	Flare Traversable LT?	N/A	N/A	Flare Traversable RT?	N/A
N/A	Landing Length (in)	N/A	N/A	DWS Provided?	N/A
N/A	Landing Width (in)	N/A	N/A	DWS Contrast?	N/A
N/A	Landing Slope (%)	N/A	N/A	DWS Length (in)	N/A
N/A	Landing X Slope (%)	N/A	N/A	DWS Full Width?	N/A
N/A	Landing Curb? (Y/N)	N/A	N/A	DWS Offset (in)	N/A
N/A	Shared Landing?	N/A			
N/A	Gutter Ponding?	N/A	N/A	Gutter Slope (%)	N/A
N/A	Gutter Lip Ht (in)	N/A	N/A	Gutter X Slope (%)	N/A
N/A	Painted X Walk1?	No	N/A	Painted X Walk2?	N/A
	X Walk 1 Direction	To S		X Walk 2 Direction	N/A
N/A	X Walk 1 Width (in)	N/A	N/A	X Walk 2 Width (in)	N/A
	X Walk 1 Slope (%)	2.1		X Walk 2 Slope (%)	N/A
	X Walk 1 X Slope (%)	4.3		X Walk 2 X Slope (%)	N/A

N/A	Ramp inside XWalk1?	N/A	N/A	Ramp inside XWalk2?	N/A
	Road Slope (%)	N/A	N/A	Clear Space?	N/A
	Road X Slope (%)	N/A	N/A	Clear Space to XWalk (in)	N/A
N/A	Any Obstructions?	N/A	N/A	Storm Grate/Utility Hazard?	N/A
	Obstruction Type			Storm Grate/Utility Type	
		N/A			N/A
			Yes	Surface Condition? (G/P)	Good

**Remove & Replace Entire Ramp.**

Total Cost: \$ 1850.00
