Intersection ID: 41209	Main Street: SACKETT_WY	Cross Street: CLYMER_CT	Location:	SW
ADA ID: E68B21B4660F	Ramp Type: PerpDiag	Initial Pass/Fail: Fail	Overall Compliance: No	Severity Score: 8.75

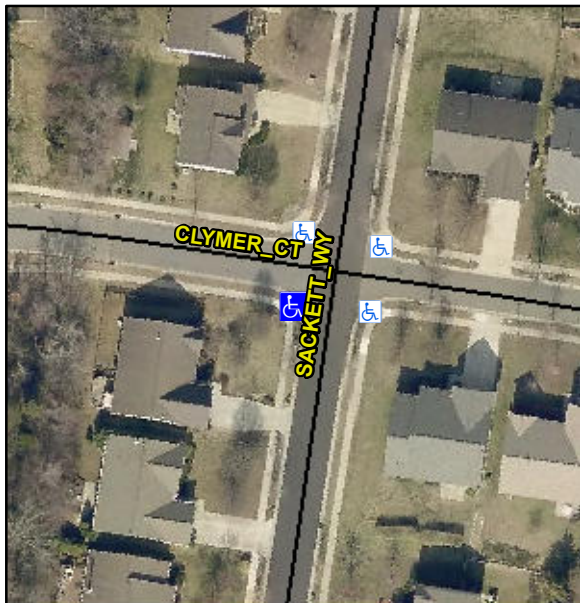
Possible Solutions:		Compliance	Description	Data	Compliance	Description	Data
	Remove & Replace Curb Ramp With Two New Directional Ramps or Equivalent.		N/A	Ramp Length (in)	48.0	Yes	Ramp Slope (%)	5.8
			No	Ramp Width (in)	47.5	Yes	Ramp XSlope (%)	0.7
			N/A	Flare Type LT	N/A	N/A	Flare Type RT	N/A
			N/A	Flare Slope LT (%)	N/A	N/A	Flare Slope RT (%)	N/A
			N/A	Flare Traversable LT?	N/A	N/A	Flare Traversable RT?	N/A
			N/A	Landing Length (in)	N/A	N/A	DWS Provided?	N/A
	Surveyor Notes:  N/A		N/A	Landing Width (in)	N/A	N/A	DWS Contrast?	N/A
			N/A	Landing Slope (%)	N/A	N/A	DWS Length (in)	N/A
			N/A	Landing X Slope (%)	N/A	N/A	DWS Full Width?	N/A
N/A			Landing Curb? (Y/N)	N/A	N/A	DWS Offset (in)	N/A	
N/A			Shared Landing?	N/A				
N/A			Gutter Ponding?	N/A	N/A	Gutter Slope (%)	N/A	
PROW/ADA:  Not Found, R304.5.1		N/A	Gutter Lip Ht (in)	N/A	N/A	Gutter X Slope (%)	N/A
