# Access Compliance Report

## Public Rights-of-Way

### (Curb Ramps)

| Intersection ID: 12632 | Main Street: SEIGLE_AV | Cross Street: SKYLINE_VIEW_WY | Location: W |

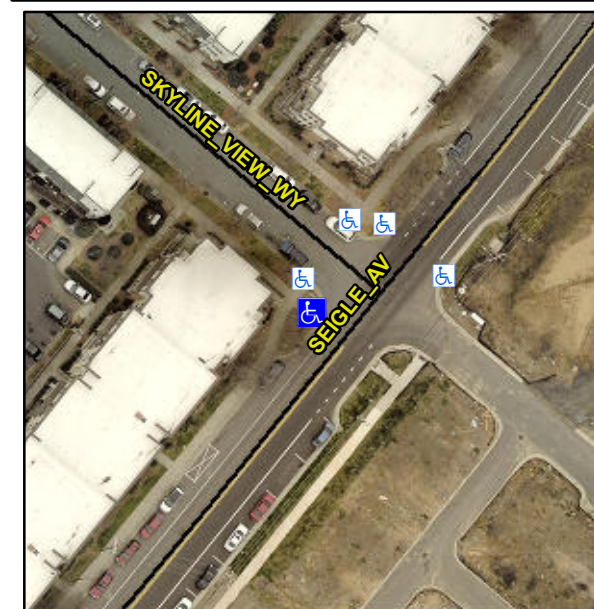
**R304.5.3, R302.7.2**

| Compliance | Description | Data | Compliance | Description | Data |
|---|---|---|---|---|---|
| No | Landing X Slope (%) | 3.1 | Yes | DWS Full Width? | Yes |
| No | Gutter Lip Ht (in) | 0.3 | Yes | Gutter X Slope (%) | 4.5 |

**Remove & Replace Landing. Grind Gutter Lip.**

Total Cost: \$ 700.00
