Access Compliance Report

Public Rights-of-Way

(Curb Ramps)

Intersection ID: 47404	Main Street: CYPRESS RIDGE DR	Cross Street: PENNINGER_CR	Location:	W
ADA ID: E69857DADF63	Ramp Type: Perp	Initial Pass/Fail: Fail	Overall Compliance: No	Severity Score: 37.5
Codes/Mitigation Info/Possible Solution		Field Measurements/Component Compliance

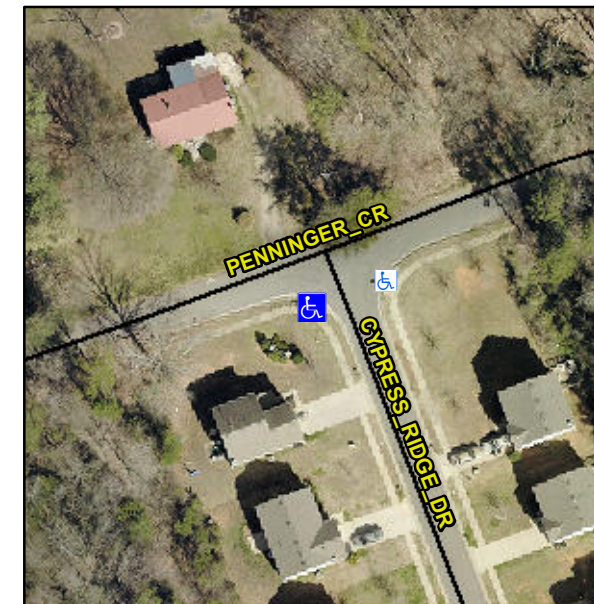
Not Found, R304.2.2, R304.5.3

Compliance	Description	Data	Compliance	Description	Data
N/A	Ramp Length (in)	48.0	No	Ramp Slope (%)	9.3
Yes	Ramp Width (in)	48.0	No	Ramp XSlope (%)	9.0
N/A	Flare Type LT	N/A	N/A	Flare Type RT	N/A
N/A	Flare Slope LT (%)	N/A	N/A	Flare Slope RT (%)	N/A
N/A	Flare Traversable LT?	N/A	N/A	Flare Traversable RT?	N/A
N/A	Landing Length (in)	N/A	N/A	DWS Provided?	N/A
N/A	Landing Width (in)	N/A	N/A	DWS Contrast?	N/A
N/A	Landing Slope (%)	N/A	N/A	DWS Length (in)	N/A
N/A	Landing X Slope (%)	N/A	N/A	DWS Full Width?	N/A
N/A	Landing Curb? (Y/N)	N/A	N/A	DWS Offset (in)	N/A
N/A	Shared Landing?	N/A			
N/A	Gutter Ponding?	N/A	N/A	Gutter Slope (%)	N/A
N/A	Gutter Lip Ht (in)	N/A	N/A	Gutter X Slope (%)	N/A
N/A	Painted X Walk1?	No	N/A	Painted X Walk2?	N/A
	X Walk 1 Direction	To E		X Walk 2 Direction	N/A
N/A	X Walk 1 Width (in)	N/A	N/A	X Walk 2 Width (in)	N/A
	X Walk 1 Slope (%)	5.3		X Walk 2 Slope (%)	N/A
	X Walk 1 X Slope (%)	6.1		X Walk 2 X Slope (%)	N/A

N/A	Ramp inside XWalk1?	N/A	N/A	Ramp inside XWalk2?	N/A
	Road Slope (%)	N/A	N/A	Clear Space?	N/A
	Road X Slope (%)	N/A	N/A	Clear Space to XWalk (in)	N/A
N/A	Any Obstructions?	N/A	N/A	Storm Grate/Utility Hazard?	N/A
	Obstruction Type			Storm Grate/Utility Type	
		N/A			N/A
			Yes	Surface Condition? (G/P)	Good

Possible Solutions:

Remove & Replace Entire Ramp.
