Access Compliance Report

Public Rights-of-Way

(Curb Ramps)

Intersection ID: N/A	Main Street: WILTHSHIRE_MANOR_DR	Cross Street: LADBROKE_CT	Location: NW
ADA ID: E6993F2B1618	Ramp Type: Directional1	Initial Pass/Fail: Fail	Overall Compliance: No
		Severity Score: 1.25

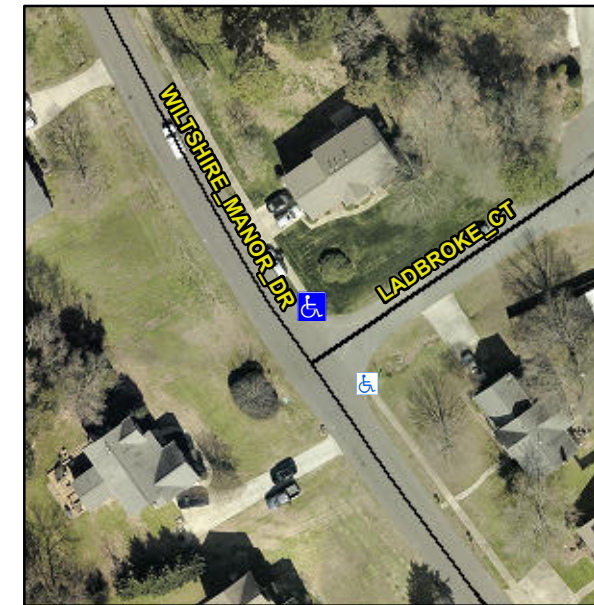
R304.5.3

Compliance	Description	Data	Compliance	Description	Data
N/A	Ramp Length (in)	49.0	N/A	Grade Break?	N/A
Yes	Ramp Width (in)	48.0	N/A	Grade Break Slope (%)	0.0
Yes	Ramp Slope (%)	0.6	N/A	Grade Break XSlope (%)	0.0
No	Ramp XSlope (%)	3.3			
N/A	Flare Type LT	N/A	N/A	Flare Type RT	N/A
N/A	Flare Slope LT (%)	N/A	N/A	Flare Slope RT (%)	0.0
N/A	Flare Traversable LT?	N/A	N/A	Flare Traversable RT?	N/A
N/A	Landing Length (in)	0.0	N/A	DWS Provided?	N/A
N/A	Landing Width (in)	0.0	N/A	DWS Contrast?	N/A
N/A	Landing Slope (%)	0.0	N/A	DWS Length (in)	N/A
N/A	Landing X Slope (%)	0.0	N/A	DWS Full Width?	N/A
N/A	Landing Curb? (Y/N)	N/A	N/A	DWS Offset LT (in)	N/A
N/A	Shared Landing?	N/A	N/A	DWS Offset RT (in)	N/A
N/A	Gutter Ponding?	0.0	N/A	Gutter Slope (%)	N/A
N/A	Gutter Lip Ht (in)	0.0	N/A	Gutter X Slope (%)	N/A
N/A	Painted X Walk1?	No		Road Slope (%)	1.6
	X Walk 1 Direction	To SE		Road X Slope (%)	2.1
	X Walk 1 Width (in)	N/A		Clear Space?	N/A

X Walk 1 Slope (%)	1.6	N/A	Clear Space to XWalk (in)	N/A
	X Walk 1 X Slope (%)	2.1	N/A	Storm Grate/Utility Hazard?	N/A
N/A	Ramp inside XWalk1?	N/A		Storm Grate/Utility Type	
N/A	Any Obstructions?	N/A			N/A
	Obstruction Type		Yes	Surface Condition? (G/P)	Good
			N/A	Curb Slope (%)	0.3

Remove & Replace Entire Ramp.
