Access Compliance Report

Public Rights-of-Way

(Curb Ramps)

Intersection ID: 18963	Main Street: GROVER_RD	Cross Street: SOUTH_BV	Location: SW
ADA ID: E6A2CB2B5B5E	Ramp Type: Perp	Initial Pass/Fail: Fail	Overall Compliance: No
Severity Score: 13.75			
Codes/Mitigation Info/Possible Solution		Field Measurements/Component Compliance

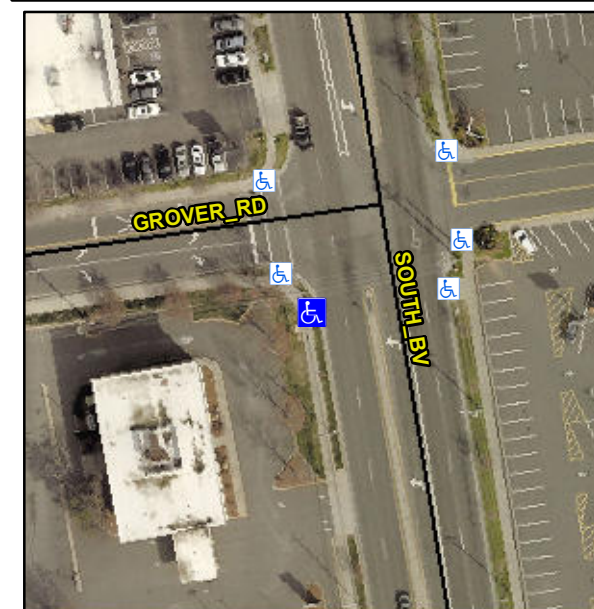
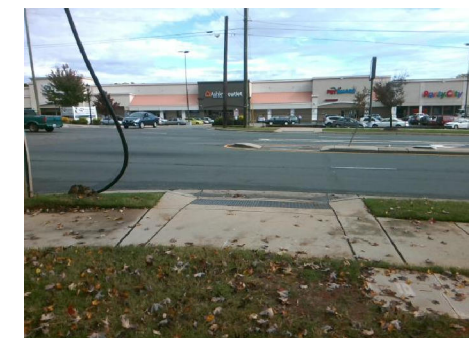
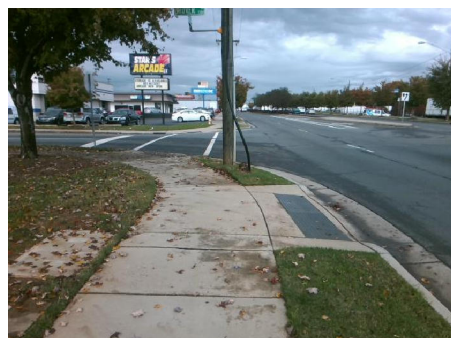
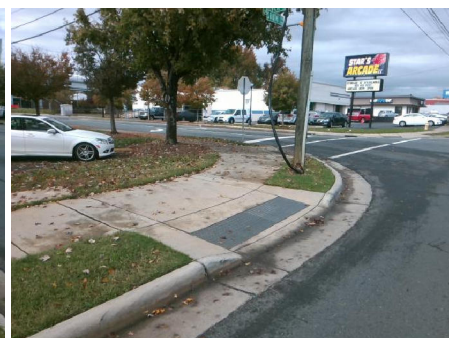
Not Found, R304.2.2, R304.5.3

Compliance	Description	Data	Compliance	Description	Data
N/A	Ramp Length (in)	47.0	No	Ramp Slope (%)	9.8
Yes	Ramp Width (in)	94.0	No	Ramp XSlope (%)	3.8
N/A	Flare Type LT	N/A	N/A	Flare Type RT	N/A
N/A	Flare Slope LT (%)	N/A	N/A	Flare Slope RT (%)	N/A
N/A	Flare Traversable LT?	N/A	N/A	Flare Traversable RT?	N/A
N/A	Landing Length (in)	N/A	N/A	DWS Provided?	N/A
N/A	Landing Width (in)	N/A	N/A	DWS Contrast?	N/A
N/A	Landing Slope (%)	N/A	N/A	DWS Length (in)	N/A
N/A	Landing X Slope (%)	N/A	N/A	DWS Full Width?	N/A
N/A	Landing Curb? (Y/N)	N/A	N/A	DWS Offset (in)	N/A
N/A	Shared Landing?	N/A			
N/A	Gutter Ponding?	N/A	N/A	Gutter Slope (%)	N/A
N/A	Gutter Lip Ht (in)	N/A	N/A	Gutter X Slope (%)	N/A
N/A	Painted X Walk1?	No	N/A	Painted X Walk2?	N/A
	X Walk 1 Direction	To E		X Walk 2 Direction	N/A
N/A	X Walk 1 Width (in)	N/A	N/A	X Walk 2 Width (in)	N/A
	X Walk 1 Slope (%)	1.8		X Walk 2 Slope (%)	N/A
	X Walk 1 X Slope (%)	1.7		X Walk 2 X Slope (%)	N/A

N/A	Ramp inside XWalk1?	N/A	N/A	Ramp inside XWalk2?	N/A
	Road Slope (%)	N/A	N/A	Clear Space?	N/A
	Road X Slope (%)	N/A	N/A	Clear Space to XWalk (in)	N/A
N/A	Any Obstructions?	N/A	N/A	Storm Grate/Utility Hazard?	N/A
	Obstruction Type			Storm Grate/Utility Type	
		N/A			N/A
			Yes	Surface Condition? (G/P)	Good

Possible Solutions:

Remove & Replace Entire Ramp.
