Access Compliance Report

Public Rights-of-Way

(Curb Ramps)

Intersection ID: 27556	Main Street: LEDERER_AV	Cross Street: QUEARY_CT	Location:	N
ADA ID: E6A74F3EE143	Ramp Type: Perp	Initial Pass/Fail: Fail	Overall Compliance: No	Severity Score: 25

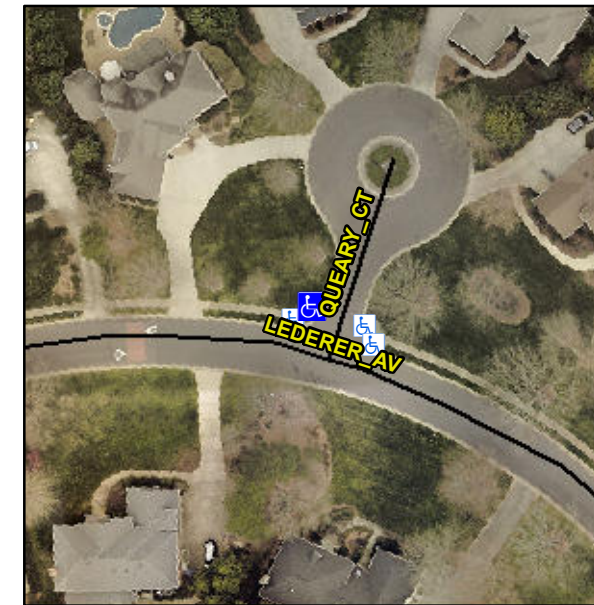
Not Found, R304.2.2, R304.5.3

Compliance	Description	Data	Compliance	Description	Data
N/A	Ramp Length (in)	48.0	No	Ramp Slope (%)	9.1
Yes	Ramp Width (in)	48.0	No	Ramp XSlope (%)	6.4
N/A	Flare Type LT	N/A	N/A	Flare Type RT	N/A
N/A	Flare Slope LT (%)	N/A	N/A	Flare Slope RT (%)	N/A
N/A	Flare Traversable LT?	N/A	N/A	Flare Traversable RT?	N/A
N/A	Landing Length (in)	N/A	N/A	DWS Provided?	N/A
N/A	Landing Width (in)	N/A	N/A	DWS Contrast?	N/A
N/A	Landing Slope (%)	N/A	N/A	DWS Length (in)	N/A
N/A	Landing X Slope (%)	N/A	N/A	DWS Full Width?	N/A
N/A	Landing Curb? (Y/N)	N/A	N/A	DWS Offset (in)	N/A
N/A	Shared Landing?	N/A			
N/A	Gutter Ponding?	N/A	N/A	Gutter Slope (%)	N/A
N/A	Gutter Lip Ht (in)	N/A	N/A	Gutter X Slope (%)	N/A
N/A	Painted X Walk1?	No	N/A	Painted X Walk2?	N/A
	X Walk 1 Direction	To SE		X Walk 2 Direction	N/A
N/A	X Walk 1 Width (in)	N/A	N/A	X Walk 2 Width (in)	N/A
	X Walk 1 Slope (%)	1.2		X Walk 2 Slope (%)	N/A
	X Walk 1 X Slope (%)	6.3		X Walk 2 X Slope (%)	N/A

N/A	Ramp inside XWalk1?	N/A	N/A	Ramp inside XWalk2?	N/A
	Road Slope (%)	N/A	N/A	Clear Space?	N/A
	Road X Slope (%)	N/A	N/A	Clear Space to XWalk (in)	N/A
N/A	Any Obstructions?	N/A	N/A	Storm Grate/Utility Hazard?	N/A
	Obstruction Type			Storm Grate/Utility Type	
		N/A			N/A
			Yes	Surface Condition? (G/P)	Good

Remove & Replace Entire Ramp.
