Access Compliance Report

Public Rights-of-Way

(Curb Ramps)

Intersection ID: 49693	Main Street: SCOTTSMAN_TRACE_DR	Cross Street: MOSS_RD	Location: SW
ADA ID: E6A7777FD6BA	Ramp Type: PerpDiag	Initial Pass/Fail: Fail	Overall Compliance: No
Codes/Mitigation Info/Possible Solution		Field Measurements/Component Compliance	
Severity Score: 12.5

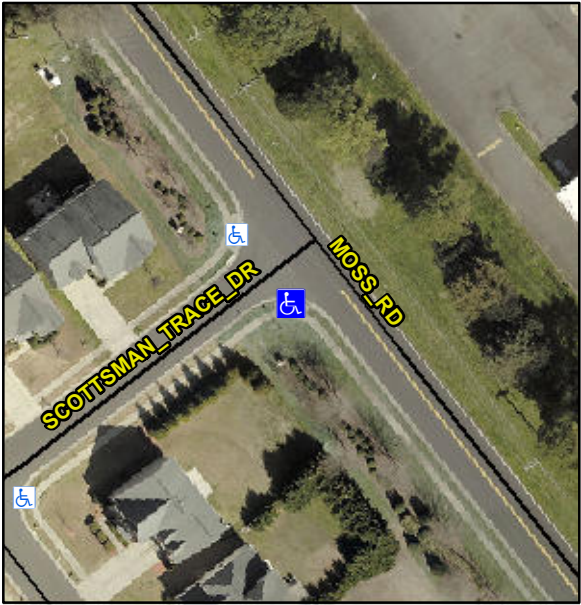
Possible Solutions:						
	Remove & Replace Curb Ramp With Two New Directional Ramps or Equivalent.	N/A	Ramp Length (in)	47.0	No	Ramp Slope (%)	9.4
		Yes	Ramp Width (in)	48.0	Yes	Ramp XSlope (%)	0.8
		N/A	Flare Type LT	N/A	N/A	Flare Type RT	N/A
		N/A	Flare Slope LT (%)	N/A	N/A	Flare Slope RT (%)	N/A
		N/A	Flare Traversable LT?	N/A	N/A	Flare Traversable RT?	N/A
		N/A	Landing Length (in)	N/A	N/A	DWS Provided?	N/A
		N/A	Landing Width (in)	N/A	N/A	DWS Contrast?	N/A
		N/A	Landing Slope (%)	N/A	N/A	DWS Length (in)	N/A
		N/A	Landing X Slope (%)	N/A	N/A	DWS Full Width?	N/A
<p>Surveyor Notes:</p> <p>N/A</p> <p>PROW/ADA:</p> <p>R304.2.2</p>		N/A	Landing Curb? (Y/N)	N/A	N/A	DWS Offset (in)	N/A
		N/A	Shared Landing?	N/A			
		N/A	Gutter Ponding?	N/A	N/A	Gutter Slope (%)	N/A
		N/A	Gutter Lip Ht (in)	N/A	N/A	Gutter X Slope (%)	N/A
		N/A	Painted X Walk1?	No	N/A	Painted X Walk2?	No
			X Walk 1 Direction	To NE		X Walk 2 Direction	To NW

N/A	X Walk 1 Width (in)	N/A	N/A	X Walk 2 Width (in)	N/A
			X Walk 1 Slope (%)	2.2		X Walk 2 Slope (%)	2.9
			X Walk 1 X Slope (%)	2.4		X Walk 2 X Slope (%)	3.4
		N/A	Ramp inside XWalk1?	N/A	N/A	Ramp inside XWalk2?	N/A
<p>Total Cost:</p> <p>\$ 3200.00</p>			Road Slope (%)	2.9	N/A	Clear Space?	N/A
			Road X Slope (%)	5.5	N/A	Clear Space to XWalk (in)	N/A
		N/A	Any Obstructions?	N/A	N/A	Storm Grate/Utility Hazard?	N/A
			Obstruction Type			Storm Grate/Utility Type	
				N/A			N/A
					Yes	Surface Condition? (G/P)	Good
