# Access Compliance Report

## Public Rights-of-Way

### (Curb Ramps)

| Intersection ID: 27432 | Main Street: BALLANTYNE_COMMONS_PY | Cross Street: DURANT_BV | Location: NE |

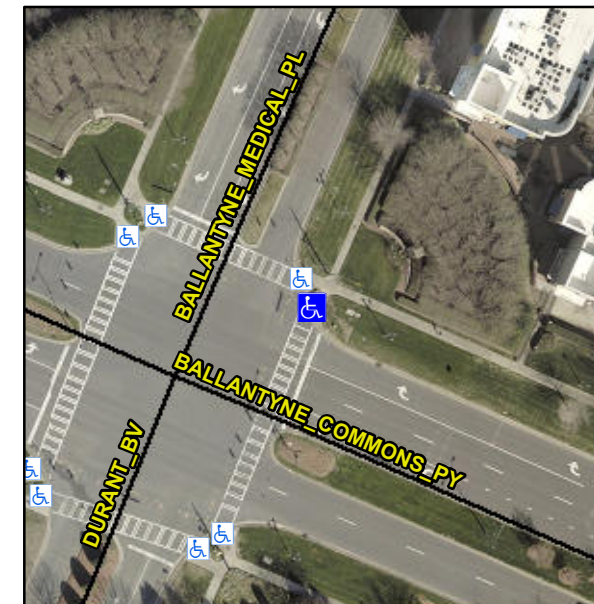
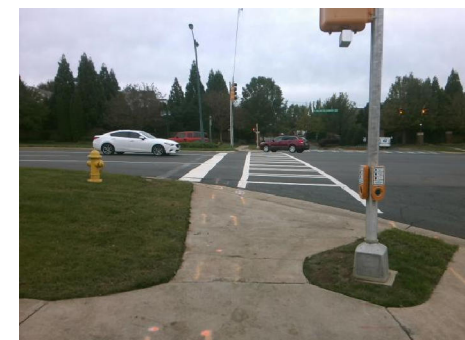
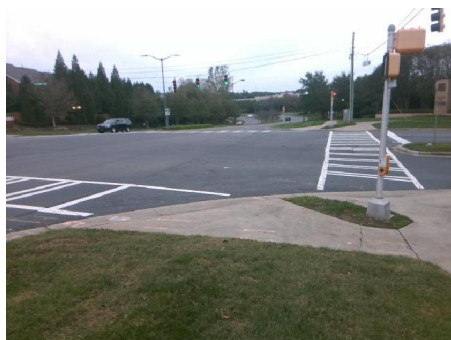
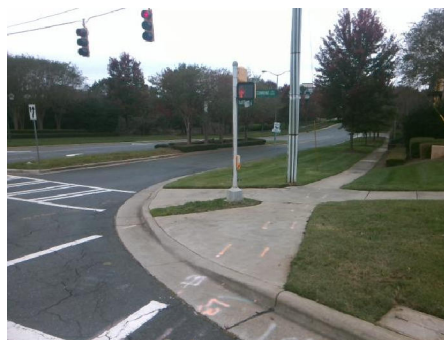
**Not Found, R304.5.3**

| Compliance | Description | Data | Compliance | Description | Data |
|---|---|---|---|---|---|
| Yes | Ramp Width (in) | 48.0 | No | BlendTrans XSlope (%) | 11.7 |
| | | | No | Curb Slope (%) | 24.4 |

**Remove & Replace Curb Ramp With Two New Directional Ramps or Equivalent.**

Total Cost: \$ 3200.00
