Intersection ID: 2901	Main Street: CRAGLAND_CT	Cross Street: HARBURN_FOREST_DR	Location:	NE
ADA ID: E6B02A7AFF63	Ramp Type: PerpDiag	Initial Pass/Fail: Pass	Overall Compliance: No	Severity Score: 17.75

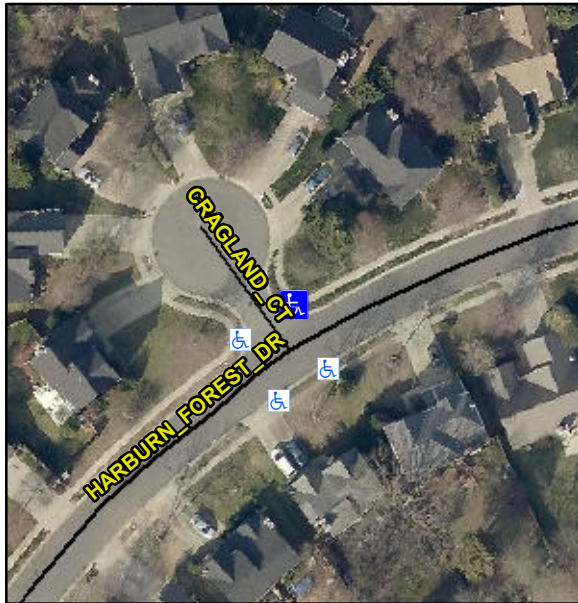
**Not Found, R304.5.3, R304.2.1,
R305, R302.7.2**

Compliance	Description	Data	Compliance	Description	Data
N/A	Ramp Length (in)	47.0	Yes	Ramp Slope (%)	7.5
Yes	Ramp Width (in)	51.0	No	Ramp XSlope (%)	2.3
N/A	Flare Type LT	None	N/A	Flare Type RT	N/A
N/A	Flare Slope LT (%)	N/A	N/A	Flare Slope RT (%)	N/A
N/A	Flare Traversable LT?	N/A	N/A	Flare Traversable RT?	N/A
No	Landing Length (in)	47.0	No	DWS Provided?	No
Yes	Landing Width (in)	51.0	N/A	DWS Contrast?	No
Yes	Landing Slope (%)	0.0	N/A	DWS Length (in)	N/A
No	Landing X Slope (%)	2.4	N/A	DWS Full Width?	No
N/A	Landing Curb? (Y/N)	No	N/A	DWS Offset (in)	N/A
N/A	Shared Landing?	No			
Yes	Gutter Ponding?	No	Yes	Gutter Slope (%)	2.8
No	Gutter Lip Ht (in)	0.5	No	Gutter X Slope (%)	2.1
N/A	Painted X Walk1?	No	N/A	Painted X Walk2?	No
	X Walk 1 Direction	To W		X Walk 2 Direction	To S
N/A	X Walk 1 Width (in)	N/A	N/A	X Walk 2 Width (in)	N/A
	X Walk 1 Slope (%)	4.8		X Walk 2 Slope (%)	1.8
	X Walk 1 X Slope (%)	0.4		X Walk 2 X Slope (%)	3.8

N/A	Ramp inside XWalk1?	N/A	N/A	Ramp inside XWalk2?	N/A
	Road Slope (%)	1.0	N/A	Clear Space?	Yes
	Road X Slope (%)	4.8	N/A	Clear Space to XWalk (in)	N/A
Yes	Any Obstructions?	No	Yes	Storm Grate/Utility Hazard?	No
	Obstruction Type			Storm Grate/Utility Type	
		N/A			N/A
			Yes	Surface Condition? (G/P)	Good

Remove & Replace Curb Ramp With Two New Directional Ramps or Equivalent. Remove & Replace Gutter.

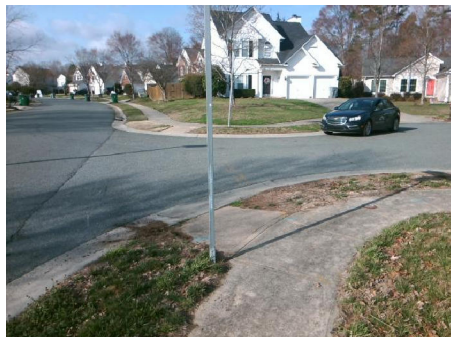
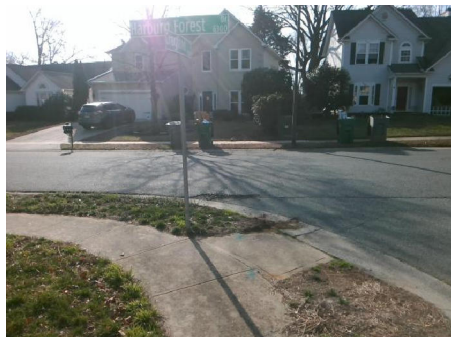
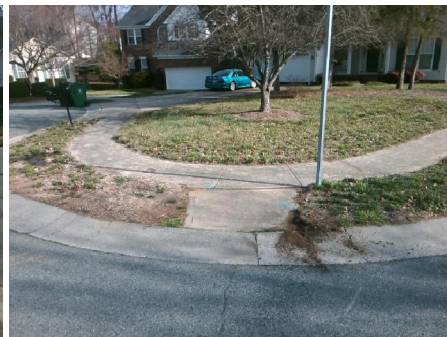
Street 1 Name	Cragland CT
Stop Condition-Street 2	StopSign
Street 2 Name	HARBURN FOREST DR
Stop Condition-Street 1	None
