Access Compliance Report

Public Rights-of-Way

(Curb Ramps)

Intersection ID: 2755	Main Street: BELL'S_MILL_DR	Cross Street: RIDGEFIELD_DR	Location: W
ADA ID: E6B344C404DC	Ramp Type: Perp	Initial Pass/Fail: Fail	Overall Compliance: No
Severity Score: 33.75			
Codes/Mitigation Info/Possible Solution		Field Measurements/Component Compliance

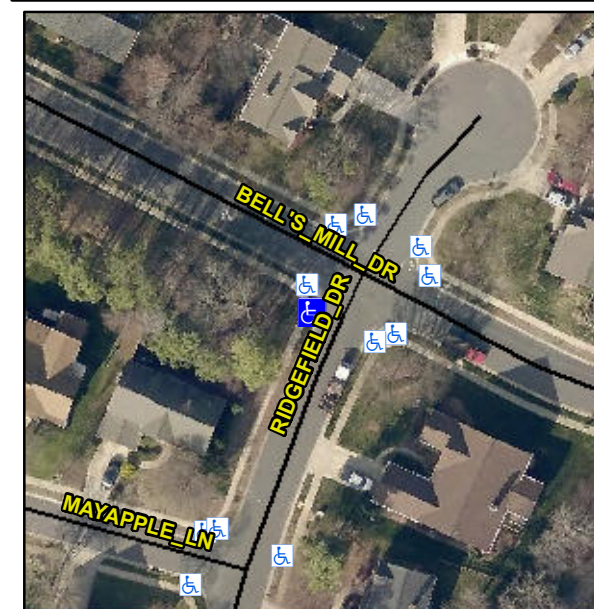
R304.5.1, R304.2.2

Compliance	Description	Data	Compliance	Description	Data
N/A	Ramp Length (in)	58.0	No	Ramp Slope (%)	13.8
No	Ramp Width (in)	36.0	Yes	Ramp XSlope (%)	0.2
N/A	Flare Type LT	N/A	N/A	Flare Type RT	N/A
N/A	Flare Slope LT (%)	N/A	N/A	Flare Slope RT (%)	N/A
N/A	Flare Traversable LT?	N/A	N/A	Flare Traversable RT?	N/A
N/A	Landing Length (in)	N/A	N/A	DWS Provided?	N/A
N/A	Landing Width (in)	N/A	N/A	DWS Contrast?	N/A
N/A	Landing Slope (%)	N/A	N/A	DWS Length (in)	N/A
N/A	Landing X Slope (%)	N/A	N/A	DWS Full Width?	N/A
N/A	Landing Curb? (Y/N)	N/A	N/A	DWS Offset (in)	N/A
N/A	Shared Landing?	N/A			
N/A	Gutter Ponding?	N/A	N/A	Gutter Slope (%)	N/A
N/A	Gutter Lip Ht (in)	N/A	N/A	Gutter X Slope (%)	N/A
N/A	Painted X Walk1?	No	N/A	Painted X Walk2?	N/A
	X Walk 1 Direction	To SE		X Walk 2 Direction	N/A
N/A	X Walk 1 Width (in)	N/A	N/A	X Walk 2 Width (in)	N/A
	X Walk 1 Slope (%)	0.7		X Walk 2 Slope (%)	N/A
	X Walk 1 X Slope (%)	2.2		X Walk 2 X Slope (%)	N/A

N/A	Ramp inside XWalk1?	N/A	N/A	Ramp inside XWalk2?	N/A
	Road Slope (%)	N/A	N/A	Clear Space?	N/A
	Road X Slope (%)	N/A	N/A	Clear Space to XWalk (in)	N/A
N/A	Any Obstructions?	N/A	N/A	Storm Grate/Utility Hazard?	N/A
	Obstruction Type			Storm Grate/Utility Type	
		N/A			N/A
			Yes	Surface Condition? (G/P)	Good

Remove & Replace Entire Ramp.
