# Access Compliance Report

## Public Rights-of-Way

### (Curb Ramps)

| Intersection ID: 27325 | Main Street: TILLEY_MORRIS_RD | Cross Street: N/A | Location: N |

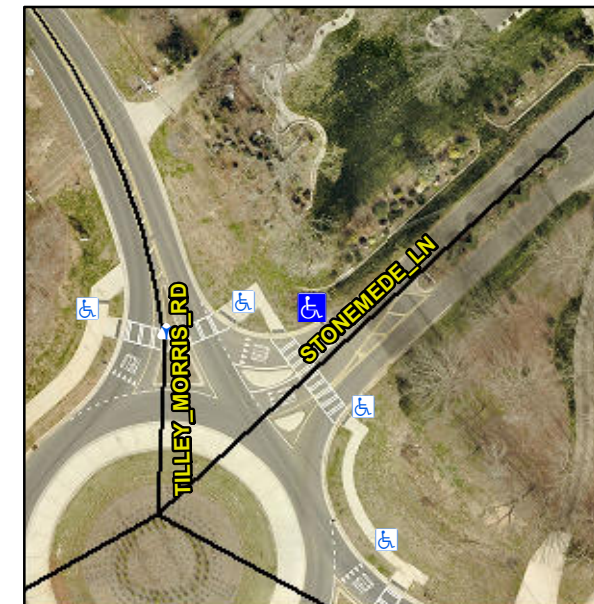
| ADA ID: E6B68C293DF5 | Ramp Type: Directional1 | Initial Pass/Fail: Pass | Overall Compliance: No |

Surveyor Notes:

**N/A**

**R304.2.2-Perp, R304.3.2-Para, R304.5.2**

| Compliance | Description | Data | Compliance | Description | Data |
|---|---|---|---|---|---|
| No | Landing Slope (%) | 2.9 | Yes | DWS Length (in) | 24.0 |

Possible Solutions:

**Remove & Replace Entire Ramp.**

Total Cost: \$ 1600.00
