# Access Compliance Report

## Public Rights-of-Way

### (Curb Ramps)

| Intersection ID: 31460 | Main Street: BOMAR_DR | Cross Street: HAMILTON_OAKS_DR | Location: NW |

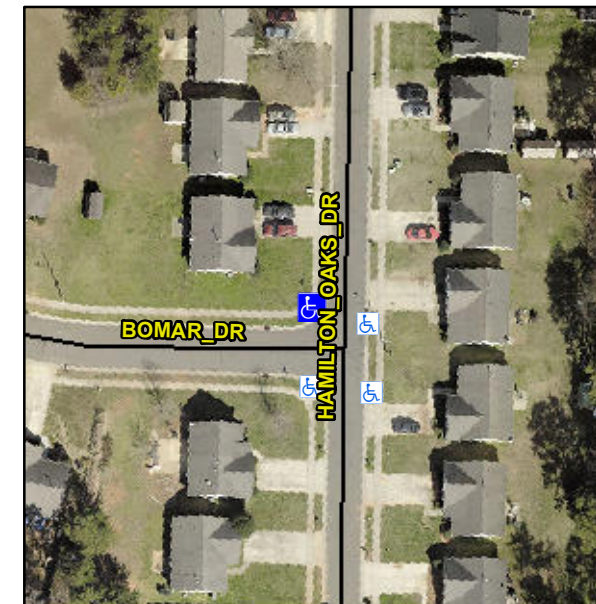
| ADA ID: E6C85BFCDAAA | Ramp Type: PerpDiag | Initial Pass/Fail: Pass | Overall Compliance: No |
| Severity Score: 25 | | | |

**Not Found, R304.2.1, R304.2.2-Perp, R304.3.2-Para, R304.5.3, R305, R304.5.4**

| Compliance | Description | Data | Compliance | Description | Data |
|---|---|---|---|---|---|
| No | Landing Length (in) | N/A | No | DWS Provided? | No |
| No | Landing Width (in) | N/A | N/A | DWS Contrast? | No |
| No | Landing Slope (%) | N/A | N/A | DWS Length (in) | N/A |
| No | Landing X Slope (%) | N/A | N/A | DWS Full Width? | No |
| Yes | Gutter Ponding? | No | No | Gutter Slope (%) | 11.2 |

**Remove & Replace Curb Ramp With Two New Directional Ramps or Equivalent. Remove & Replace Gutter.**

Total Cost: \$ 3950.00
