Access Compliance Report

Public Rights-of-Way

(Curb Ramps)

Intersection ID: 11958	Main Street: E_16TH_ST	Cross Street: SEIGLE_AV	Location: S
ADA ID: E6CDCA418356	Ramp Type: Perp	Initial Pass/Fail: Fail	Overall Compliance: No
Severity Score: 1.25			
Codes/Mitigation Info/Possible Solution		Field Measurements/Component Compliance

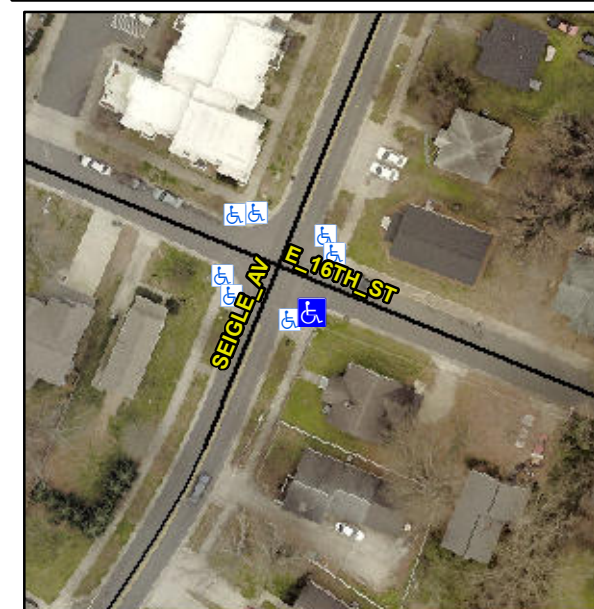
Compliance	Description	Data	Compliance	Description	Data
N/A	Ramp Length (in)	74.0	Yes	Ramp Slope (%)	5.0
Yes	Ramp Width (in)	50.0	No	Ramp XSlope (%)	2.8
N/A	Flare Type LT	N/A	N/A	Flare Type RT	N/A
N/A	Flare Slope LT (%)	N/A	N/A	Flare Slope RT (%)	N/A
N/A	Flare Traversable LT?	N/A	N/A	Flare Traversable RT?	N/A
N/A	Landing Length (in)	N/A	N/A	DWS Provided?	N/A
N/A	Landing Width (in)	N/A	N/A	DWS Contrast?	N/A
N/A	Landing Slope (%)	N/A	N/A	DWS Length (in)	N/A
N/A	Landing X Slope (%)	N/A	N/A	DWS Full Width?	N/A
N/A	Landing Curb? (Y/N)	N/A	N/A	DWS Offset (in)	N/A
N/A	Shared Landing?	N/A			
N/A	Gutter Ponding?	N/A	N/A	Gutter Slope (%)	N/A
N/A	Gutter Lip Ht (in)	N/A	N/A	Gutter X Slope (%)	N/A
N/A	Painted X Walk1?	No	N/A	Painted X Walk2?	N/A
	X Walk 1 Direction	To NE		X Walk 2 Direction	N/A
N/A	X Walk 1 Width (in)	N/A	N/A	X Walk 2 Width (in)	N/A
	X Walk 1 Slope (%)	2.6		X Walk 2 Slope (%)	N/A
	X Walk 1 X Slope (%)	1.9		X Walk 2 X Slope (%)	N/A

N/A	Ramp inside XWalk1?	N/A	N/A	Ramp inside XWalk2?	N/A
	Road Slope (%)	N/A	N/A	Clear Space?	N/A
	Road X Slope (%)	N/A	N/A	Clear Space to XWalk (in)	N/A
N/A	Any Obstructions?	N/A	N/A	Storm Grate/Utility Hazard?	N/A
	Obstruction Type			Storm Grate/Utility Type	
		N/A			N/A
		Yes		Surface Condition? (G/P)	Good

Possible Solutions:

Remove & Replace Entire Ramp.

PROW/ADA:

R304.5.3
