Access Compliance Report Public Rights-of-Way (Curb Ramps)

Intersection ID: 17795 Main Street: CONNECTING_RD Cross Street: E WOODLAWN RD Location: NW
ADA ID: E6CDF28D07BA Ramp Type: ParaDiag Initial Pass/Fail: Fail Overall Compliance: No Severity Score: 26.25

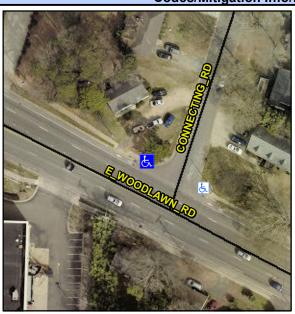
LT RP < 5%

R304.3.2, R304.5.3

| Field Measurements/Component Compilance | | | | | |
|---|--|---|---|---|---|
| Yes | Ramp Slope LT (%) | 2.4 | No | Ramp Slope RT (%) | 15.5 |
| Yes | Ramp XSlope LT (%) | 1.8 | No | Ramp XSlope RT (%) | 3.9 |

Remove & Replace Curb Ramp With
Two New Directional Ramps or
Equivalent.

Total Cost: \$ 3200.00
