Access Compliance Report

Public Rights-of-Way

(Curb Ramps)

| Intersection ID: 52929 | Main Street: ENGLISH_OAK_LEAF_CT | Cross Street: GRAY_OAK_LN | Location: NW |

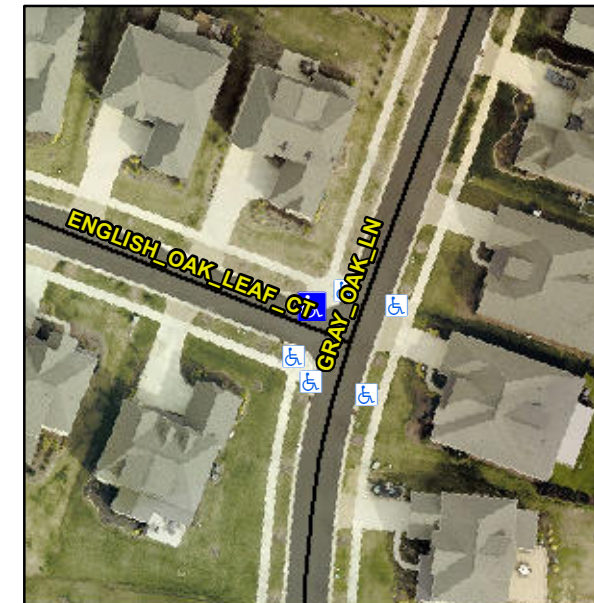
| ADA ID: E6CF727EAE5D | Ramp Type: Perp | Initial Pass/Fail: Fail | Overall Compliance: No |
| | | Severity Score: 8.75 | |

| Compliance | Description | Data | Compliance | Description | Data |
|---|---|---|---|---|---|
| No | Ramp Width (in) | 47.5 | Yes | Ramp XSlope (%) | 0.2 |

Possible Solutions:

Remove & Replace Entire Ramp.

R304.5.1
