Access Compliance Report

Public Rights-of-Way (Curb Ramps)

Intersection ID: N/A	Main Street: PROVIDENCE_RD	Cross Street: N/A	Location: W
ADA ID: E6D76B85ADF8	Ramp Type: Perp	Initial Pass/Fail: Fail	Overall Compliance: No
		Severity Score: 12.5

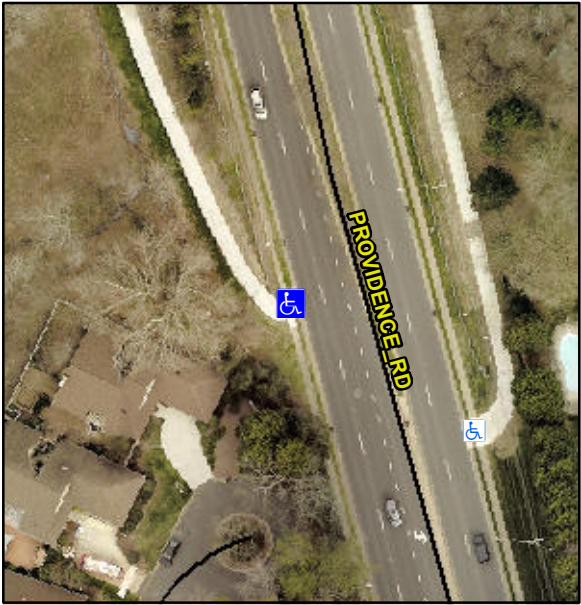
Possible Solutions:		Compliance	Description	Data
	Remove & Replace Entire Ramp.		No	Ramp Length (in)	69.0
			Yes	Ramp Width (in)	49.0
			N/A	Flare Type LT	N/A
			N/A	Flare Slope LT (%)	N/A
			N/A	Flare Traversable LT?	N/A
			N/A	Landing Length (in)	N/A
			N/A	Landing Width (in)	N/A
			N/A	Landing Slope (%)	N/A
			N/A	Landing X Slope (%)	N/A
<p>Surveyor Notes:</p> <p>N/A</p> <p>PROW/ADA:</p> <p>Not Found, R304.2.2</p>			N/A	Flare Type RT	N/A
			N/A	Flare Slope RT (%)	N/A
			N/A	Flare Traversable RT?	N/A
			N/A	DWS Provided?	N/A
			N/A	DWS Contrast?	N/A
			N/A	DWS Length (in)	N/A
			N/A	DWS Full Width?	N/A
			N/A	DWS Offset (in)	N/A
			N/A	Shared Landing?	N/A
			N/A	Gutter Ponding?	N/A
			N/A	Gutter Lip Ht (in)	N/A
			No	Painted X Walk1?	N/A
				X Walk 1 Direction	To E
			N/A	X Walk 1 Width (in)	N/A
				X Walk 1 Slope (%)	2.5
				X Walk 1 X Slope (%)	0.2

N/A	Ramp inside XWalk1?	N/A
			N/A	Ramp inside XWalk2?	N/A
			N/A	Road Slope (%)	N/A
			N/A	Road X Slope (%)	N/A
			N/A	Any Obstructions?	N/A
				Obstruction Type	
			N/A		
			N/A		
			N/A		
			N/A		
			N/A		
			N/A		
			N/A		
			N/A		
Total Cost:		\$ 1850.00			
			Yes	Surface Condition? (G/P)	Good
