## Access Compliance Report Public Rights-of-Way (Curb Ramps)

Intersection ID: 10014519Main Street: UNIVERSITY\_POINTE\_BVCross Street: N/ALocation:SWADA ID: E6D812CCD5FFRamp Type: PerpInitial Pass/Fail: FailOverall Compliance: NoSeverity Score:10

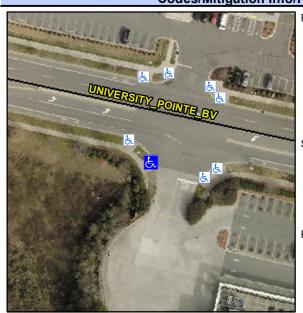
Field Measurements/Component Compliance							
Comp	oliance Description	Data	Comp	oliance Description	Data		
N/A	Ramp Length (in)	96.0	Yes	Ramp Slope (%)	6.4		
No	Ramp Width (in)	45.5	No	Ramp XSlope (%)	4.8		
N/A	Flare Type LT	N/A	N/A	Flare Type RT	N/A		
N/A	Flare Slope LT (%)	N/A	N/A	Flare Slope RT (%)	N/A		
N/A	Flare Traversable LT?	N/A	N/A	Flare Traversable RT?	N/A		
N/A	Landing Length (in)	N/A	N/A	DWS Provided?	N/A		
N/A	Landing Width (in)	N/A	N/A	DWS Contrast?	N/A		
N/A	Landing Slope (%)	N/A	N/A	DWS Length (in)	N/A		
N/A	Landing X Slope (%)	N/A	N/A	DWS Full Width?	N/A		
N/A	Landing Curb? (Y/N)	N/A	N/A	DWS Offset (in)	N/A		
N/A	Shared Landing?	N/A					
N/A	Gutter Ponding?	N/A	N/A	Gutter Slope (%)	N/A		
N/A	Gutter Lip Ht (in)	N/A	N/A	Gutter X Slope (%)	N/A		
N/A	Painted X Walk1?	No	N/A	Painted X Walk2?	N/A		
	X Walk 1 Direction	То Е		X Walk 2 Direction	N/A		
N/A	X Walk 1 Width (in)	N/A	N/A	X Walk 2 Width (in)	N/A

X Walk 1 Slope (%)	4.8		X Walk 2 Slope (%)	N/A		
	X Walk 1 X Slope (%)	2.5		X Walk 2 X Slope (%)	N/A		
N/A	Ramp inside XWalk1?	N/A	N/A	Ramp inside XWalk2?	N/A		
	Road Slope (%)	N/A	N/A	Clear Space?	N/A		
	Road X Slope (%)	N/A	N/A	Clear Space to XWalk (in)	N/A		
N/A	Any Obstructions?	N/A	N/A	Storm Grate/Utility Hazard?	N/A		
	Obstruction Type			Storm Grate/Utility Type			
		N/A			N/A		
			Yes	Surface Condition? (G/P)	Good		
4000000

71 COSIDIC COIGNON	
Possible Solutions:	<u>c</u>
Remove & Replace Entire Ramp.	N
	N
	N
	N
	N
	N
Surveyor Notes:	N
N/A	N
	N
	N
	N
PROW/ADA:	N
Not Found, R304.5.1, R304.5.3	N
	N
	N
	N
