Access Compliance Report

Public Rights-of-Way

(Curb Ramps)

Intersection ID: 30338	Main Street: DULIN_CREEK_BV	Cross Street: GARDENIA_ST	Location: NW
ADA ID: E6E5B31C176D	Ramp Type: PerpDiag	Initial Pass/Fail: Fail	Overall Compliance: No
Severity Score: 12.5			
Codes/Mitigation Info/Possible Solution		Field Measurements/Component Compliance

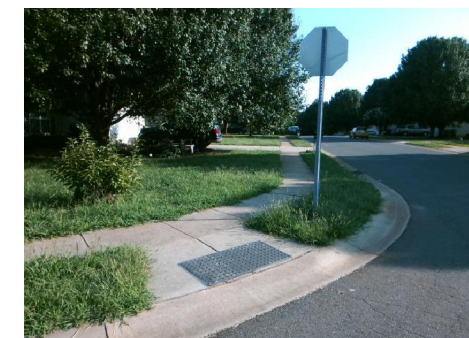
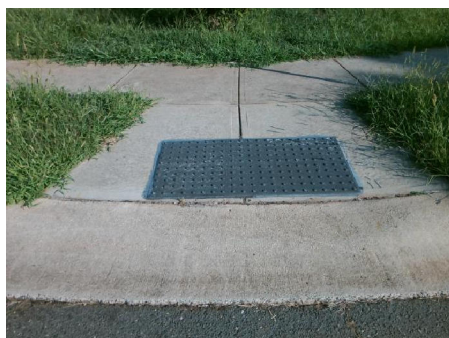
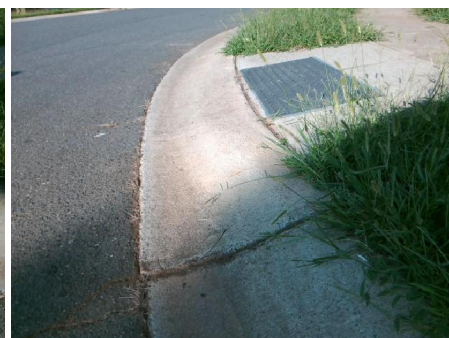
Compliance	Description	Data	Compliance	Description	Data
N/A	Ramp Length (in)	49.0	No	Ramp Slope (%)	9.3
Yes	Ramp Width (in)	48.0	Yes	Ramp XSlope (%)	0.6
N/A	Flare Type LT	N/A	N/A	Flare Type RT	N/A
N/A	Flare Slope LT (%)	N/A	N/A	Flare Slope RT (%)	N/A
N/A	Flare Traversable LT?	N/A	N/A	Flare Traversable RT?	N/A
N/A	Landing Length (in)	N/A	N/A	DWS Provided?	N/A
N/A	Landing Width (in)	N/A	N/A	DWS Contrast?	N/A
N/A	Landing Slope (%)	N/A	N/A	DWS Length (in)	N/A
N/A	Landing X Slope (%)	N/A	N/A	DWS Full Width?	N/A
N/A	Landing Curb? (Y/N)	N/A	N/A	DWS Offset (in)	N/A
N/A	Shared Landing?	N/A			
N/A	Gutter Ponding?	N/A	N/A	Gutter Slope (%)	N/A
N/A	Gutter Lip Ht (in)	0.5	N/A	Gutter X Slope (%)	N/A
N/A	Painted X Walk1?	No	N/A	Painted X Walk2?	No
	X Walk 1 Direction	To S		X Walk 2 Direction	To E
N/A	X Walk 1 Width (in)	N/A	N/A	X Walk 2 Width (in)	N/A
	X Walk 1 Slope (%)	2.1		X Walk 2 Slope (%)	0.2
	X Walk 1 X Slope (%)	0.4		X Walk 2 X Slope (%)	0.1

N/A	Ramp inside XWalk1?	N/A	N/A	Ramp inside XWalk2?	N/A
	Road Slope (%)	0.3	N/A	Clear Space?	N/A
	Road X Slope (%)	0.1	N/A	Clear Space to XWalk (in)	N/A
N/A	Any Obstructions?	N/A	N/A	Storm Grate/Utility Hazard?	N/A
	Obstruction Type			Storm Grate/Utility Type	
		N/A			N/A
			Yes	Surface Condition? (G/P)	Good

Remove & Replace Curb Ramp With Two New Directional Ramps or Equivalent.

Not Found, R304.2.2
